Status of bridge inspection 1

Bridge Repair and Reinforcement Case Studies 1

Bridge Repair and Reinforcement Case Studies 2

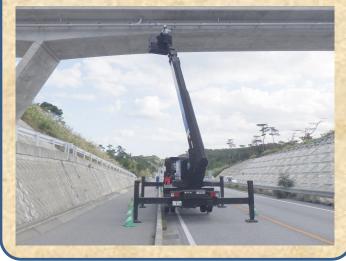
Inspecting damage to elevated bridges through close-range visual inspection
