1 世渡橋（補修工事）

世渡橋補修一般圖

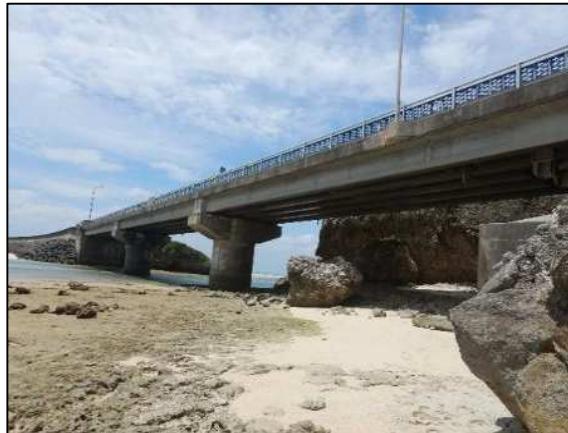
- ・昭和62年3月24日に完成
 - ・池間大橋の隣にある99mの橋梁
 - ・海上橋という塩害環境で30年以上
 - ・平成24年に上部工の補修工事、落橋防止対策を実施し、耐震性能は3
 - ・令和3年の橋梁点検で健全度Ⅲ。R4で補修設計、R6で工事を発注。
