Concrete Maintenance Engineering

- A case study of concrete structures in Okinawa -

University of the Ryukyus Faculty of Engineering
School of Engineering Civil Engineering Program

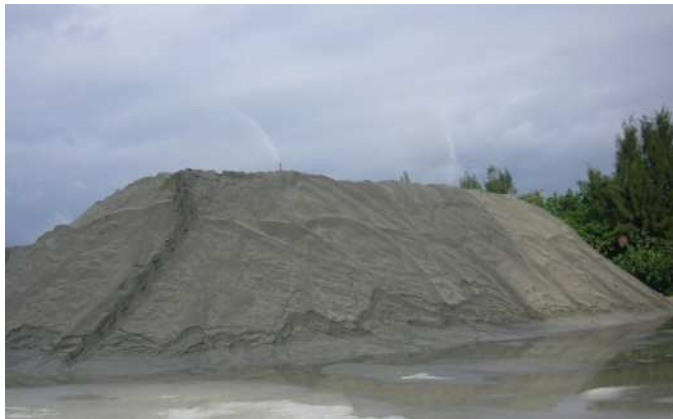
Sea sand desalination status:
Sprinkling method

【5 days = 1 process】

2,500 m³ of sand is piled up and about 3,000 tons of industrial water is sprinkled continuously for 4 days.2
Drain in 24 hours and confirm that the amount of chloride (as NaCl) is 0.04% or less.

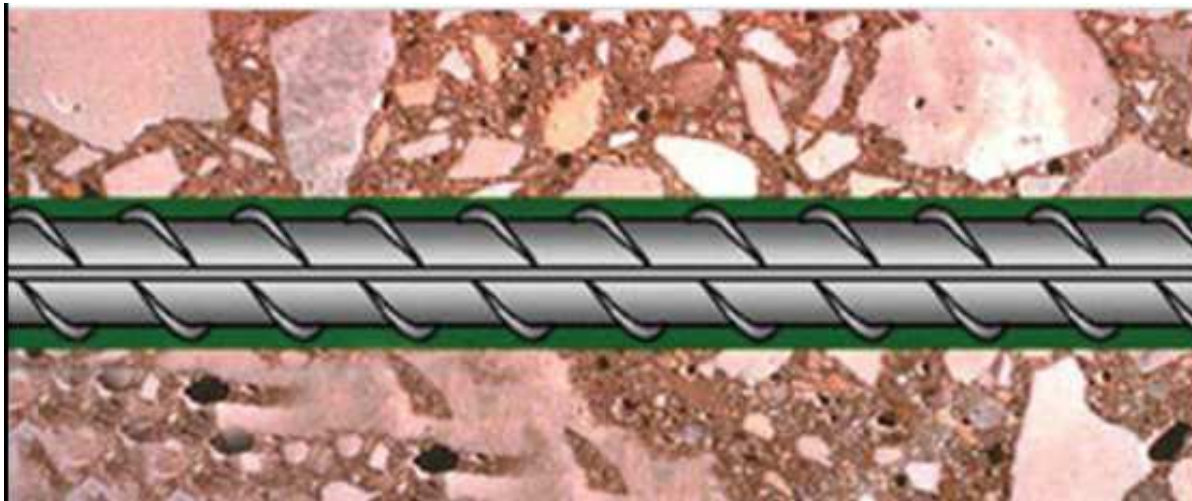
- Generally, concrete has a highly alkaline environment with pH of 12-13.
- In such an environment, a passive film (oxide film) is formed on the surface of the steel in the concrete, which inhibits steel corrosion.

Passive film

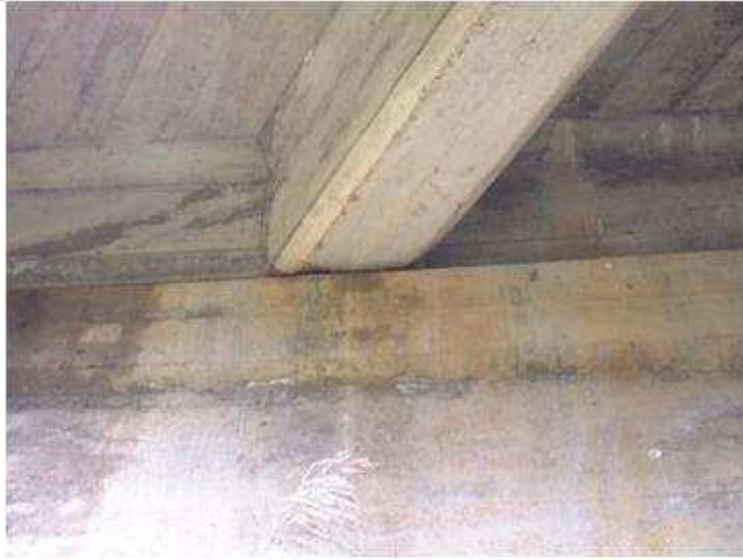
【Incubation period】 and 【Progression period】

- No deformation has occurred yet.

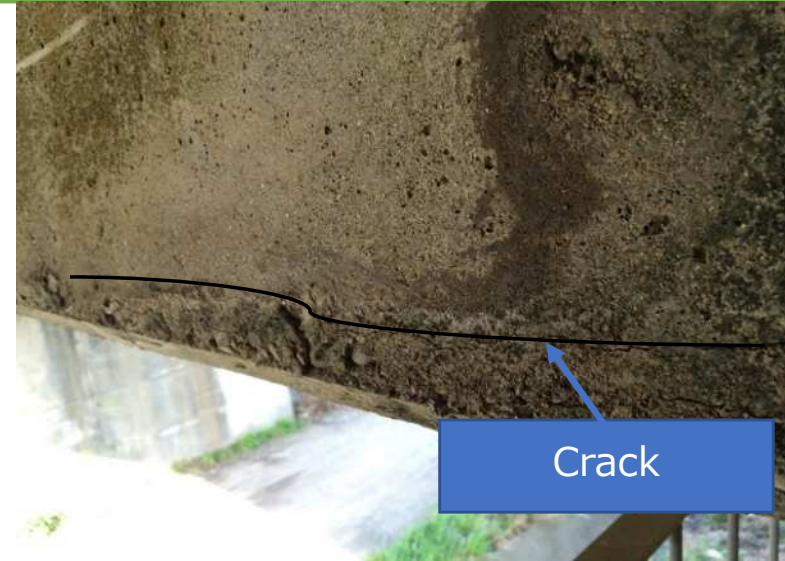
【Early acceleration period】

- Minor cracks and lifting occur.

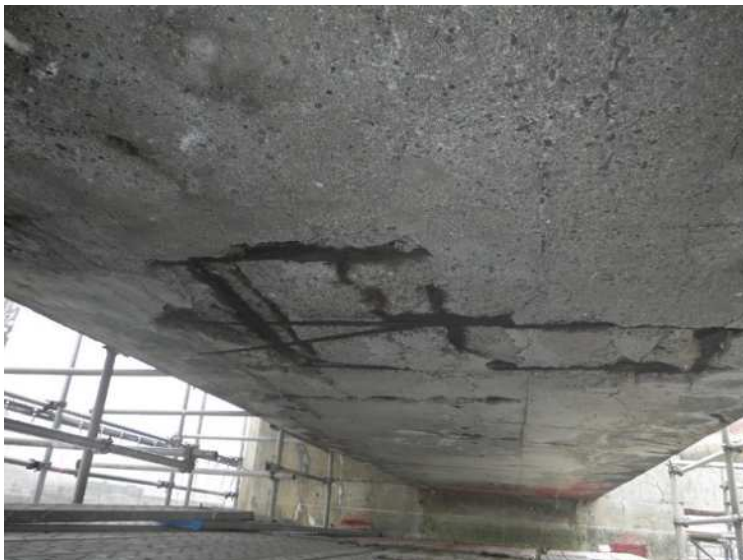
【Late acceleration period】

- Many cracks, floats, and peeling occur.

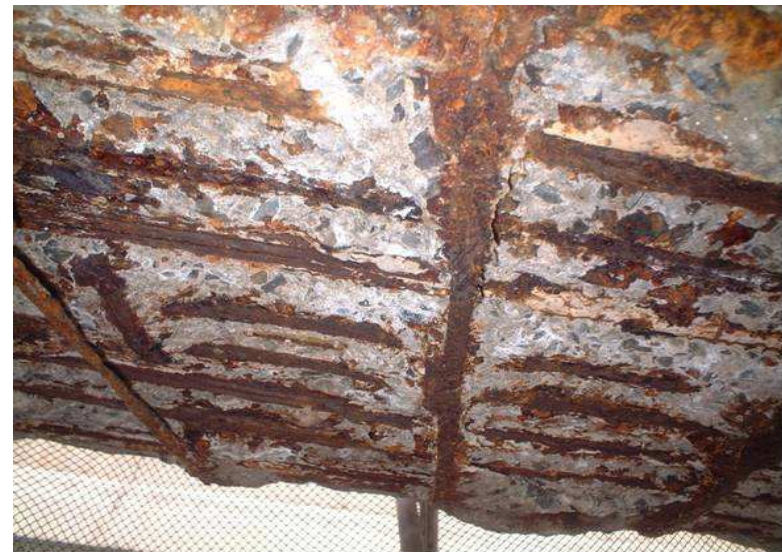
【Deterioration period】

- Large scale spalling, decrease in cross section of reinforcing rebar

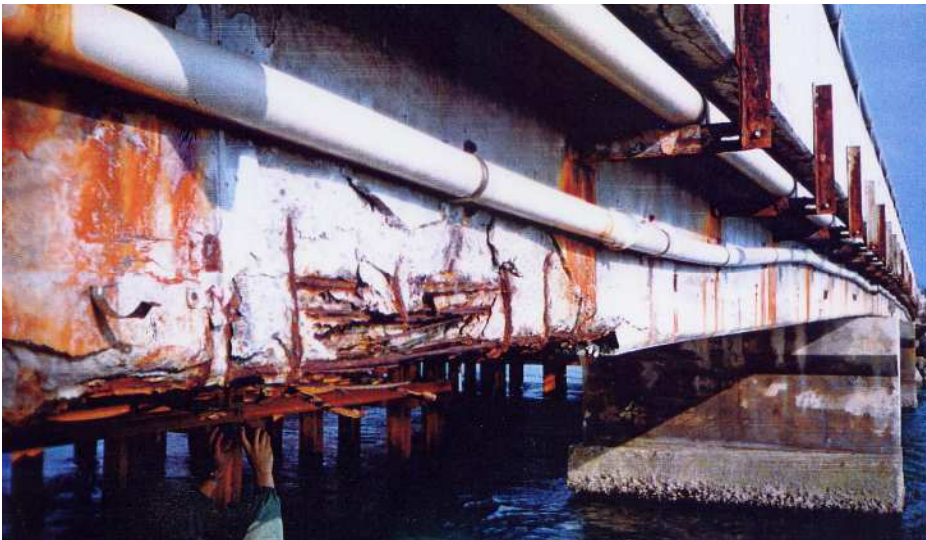
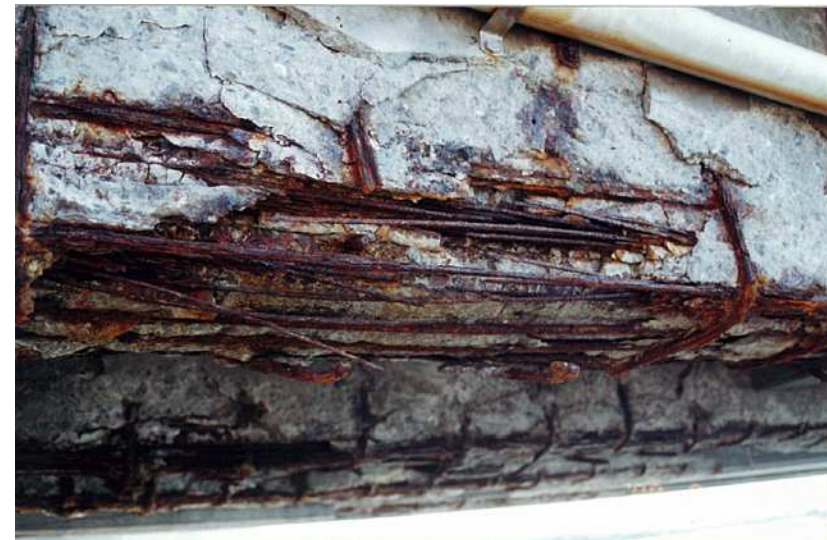
Salt damage deterioration case (former Noho Bridge)

Completed in 1978
Removed in 1999

The first remote island bridge since Okinawa returned to Japan:
After 21 years of construction, salt damage led to deterioration and replacement.

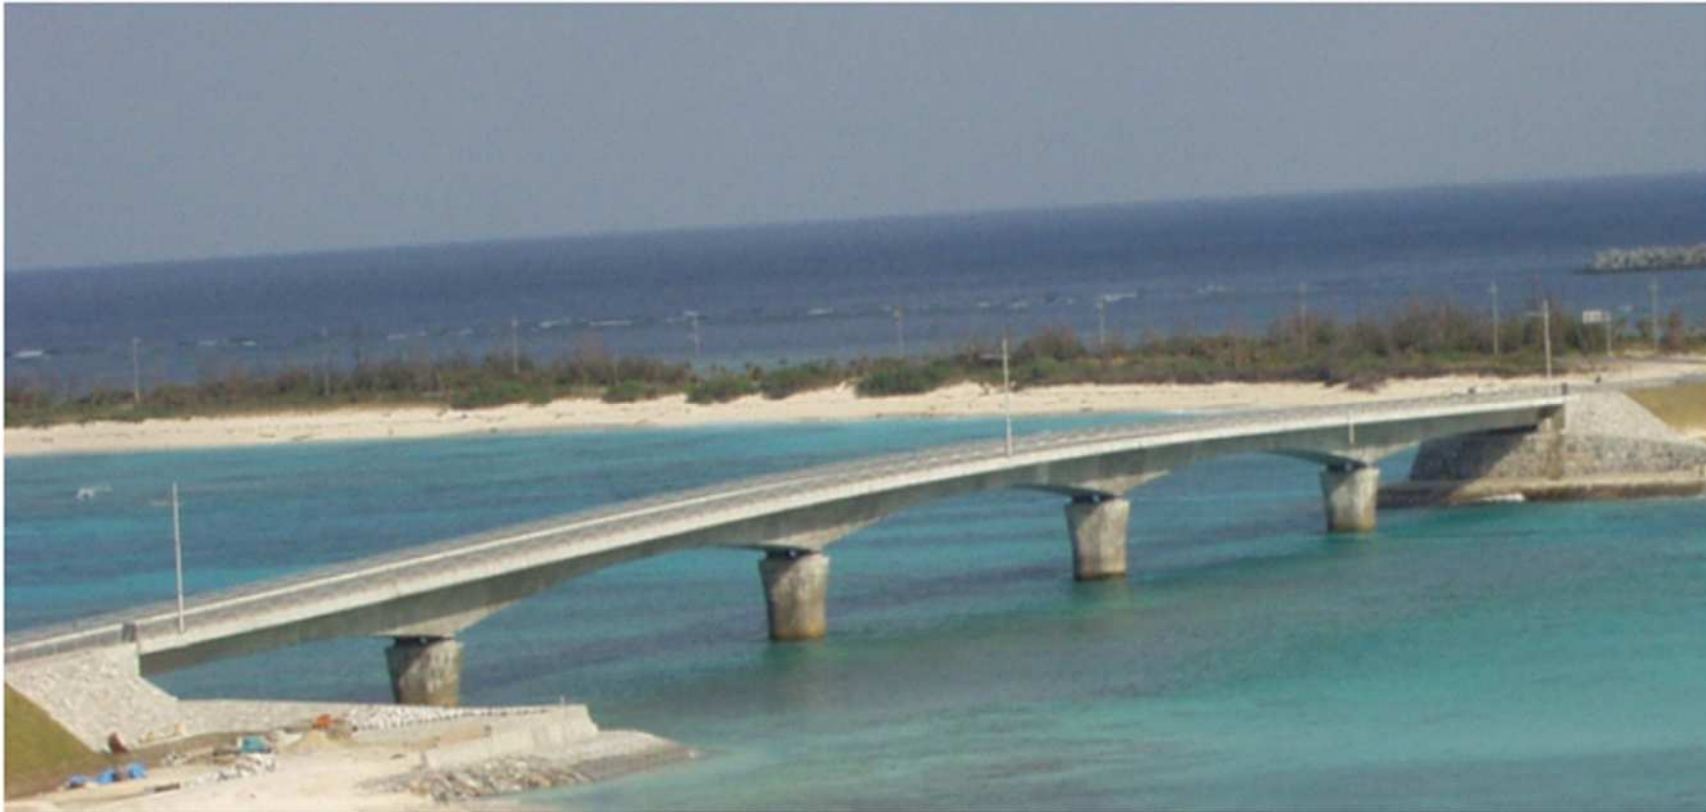
Shin Noho Bridge

PC5 spaced continuous box girder bridge

Bridge length 320m (54.25 + 3 @ 70 + 54.25)

Measures against salt damage:

1. Securing cover 70 mm
2. Adoption of epoxy resin coated reinforcing bars
3. Adoption of epoxy resin coated PC steel material
4. Adoption of polyethylene sheath

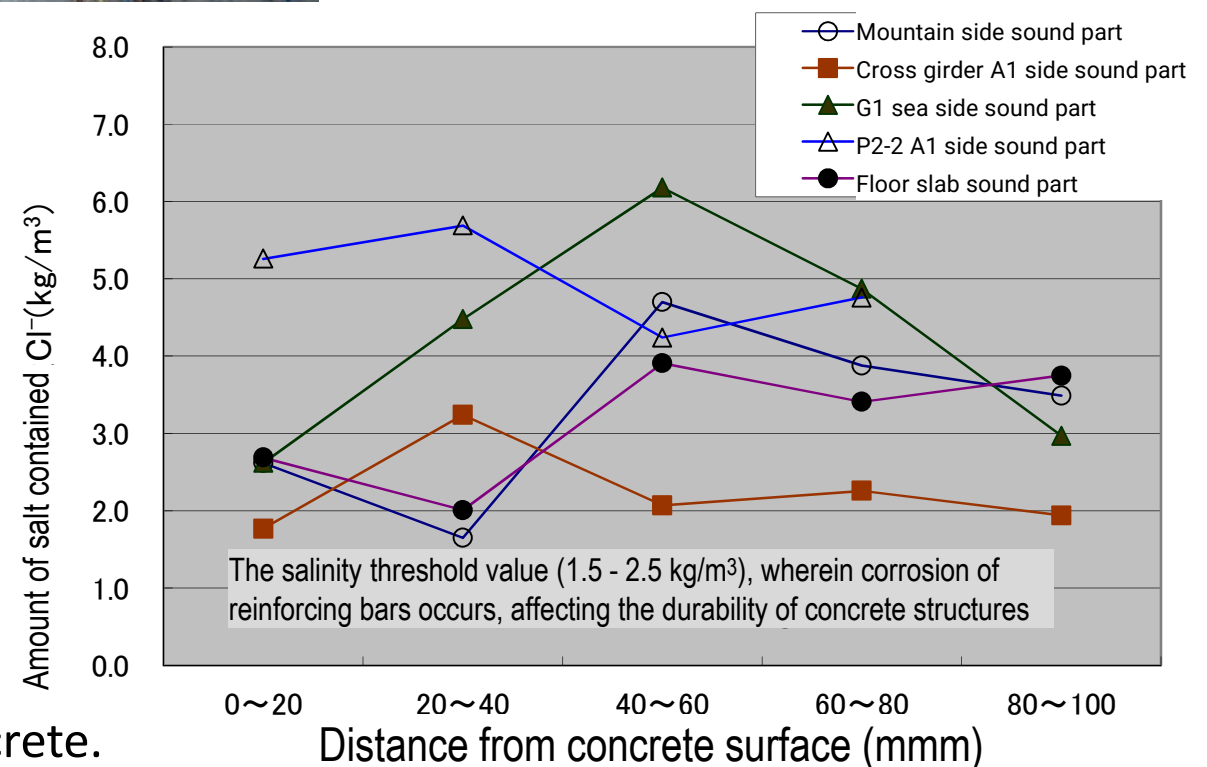
Example of salt damage: Former Kanna Bridge (RC bridge)

- Built before 1972
- Deterioration status at the time of 2001 survey
- Removed

High concentration salt exists inside concrete.

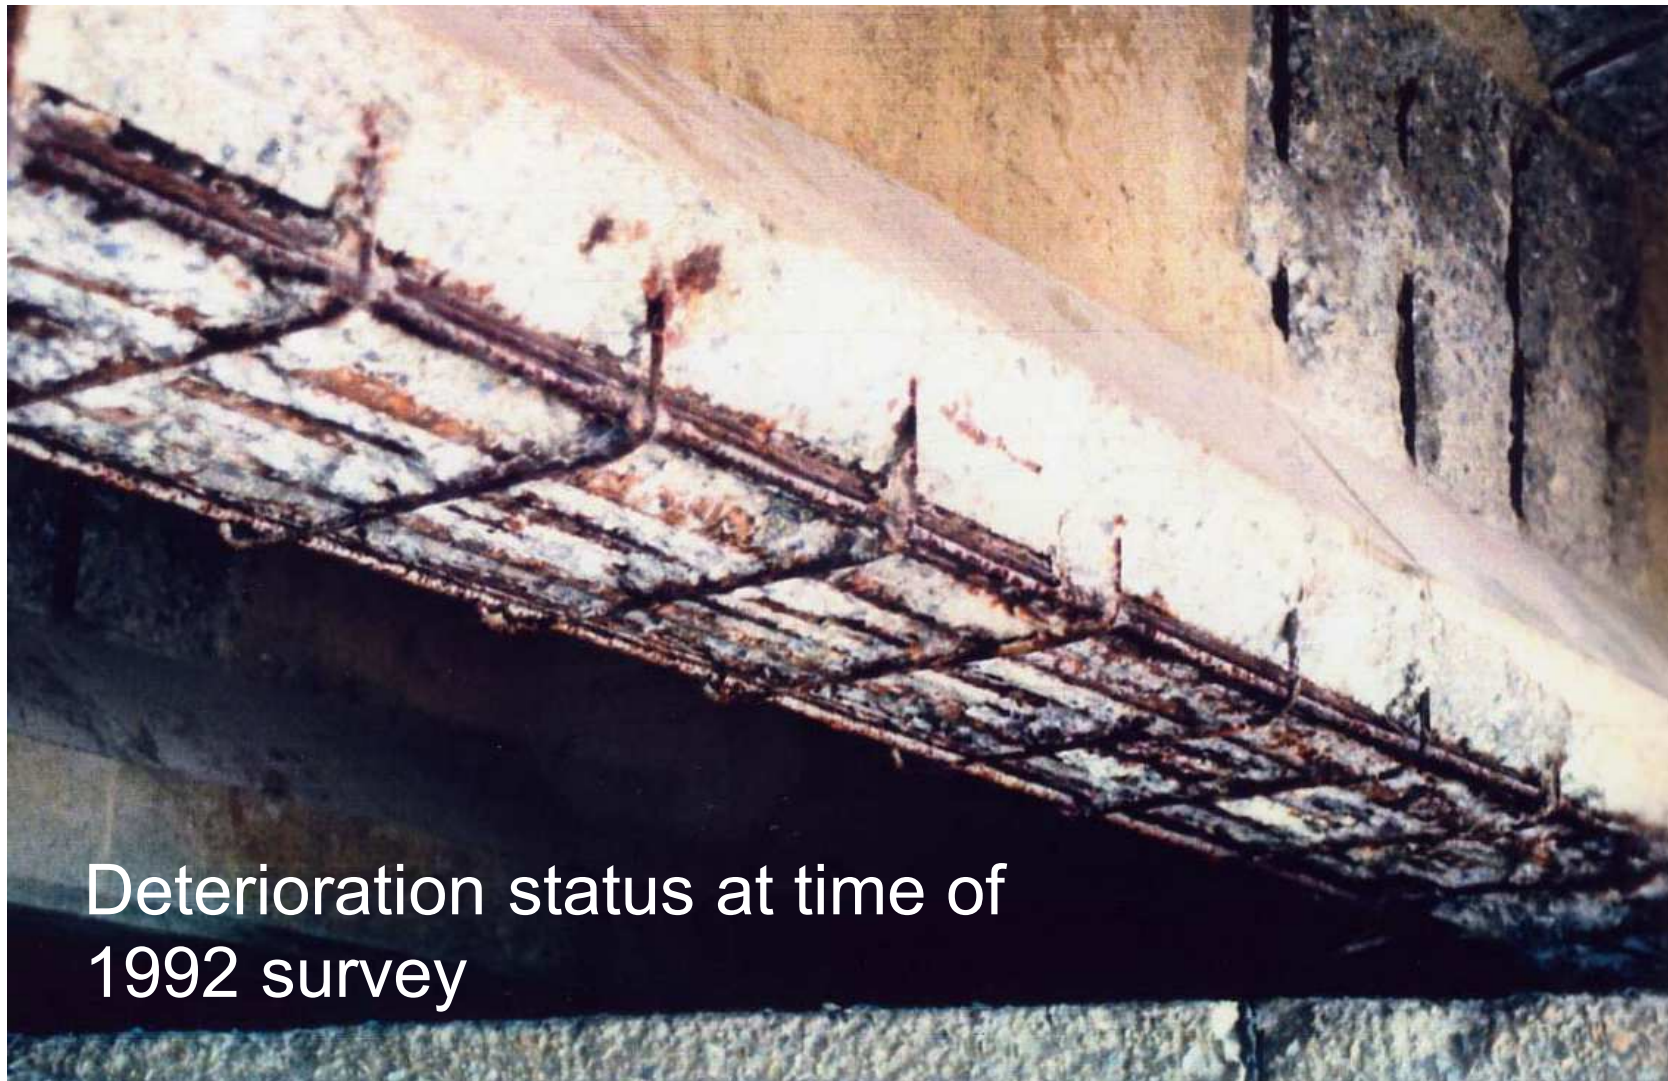
Salt damage example: PC bridge

Constructed with Ocean Expo immediately after Okinawan reversion (1975).

Deterioration status at time of
1992 survey

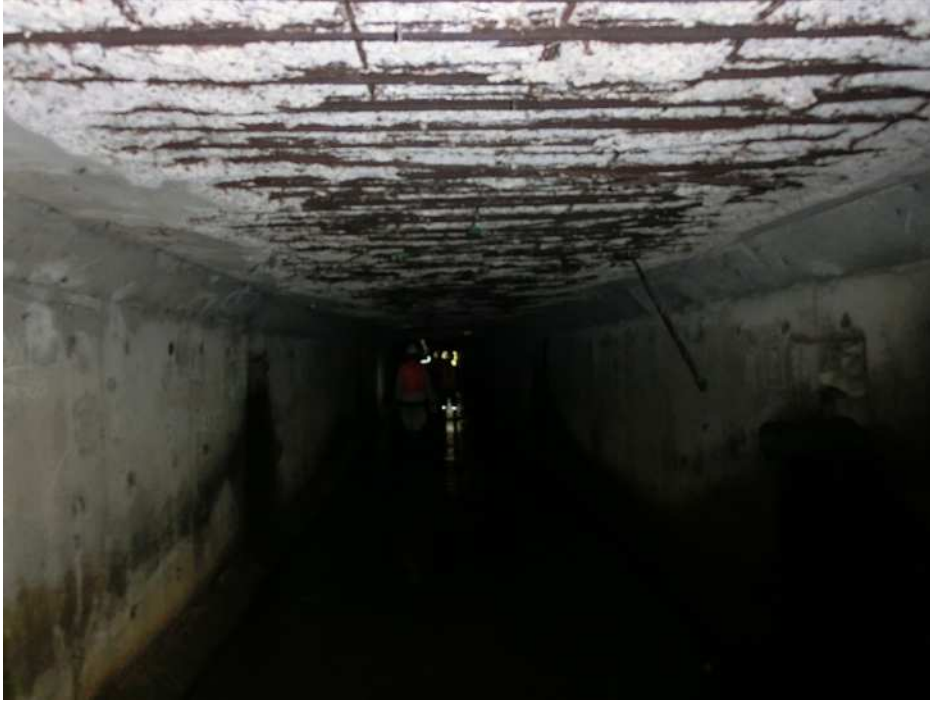
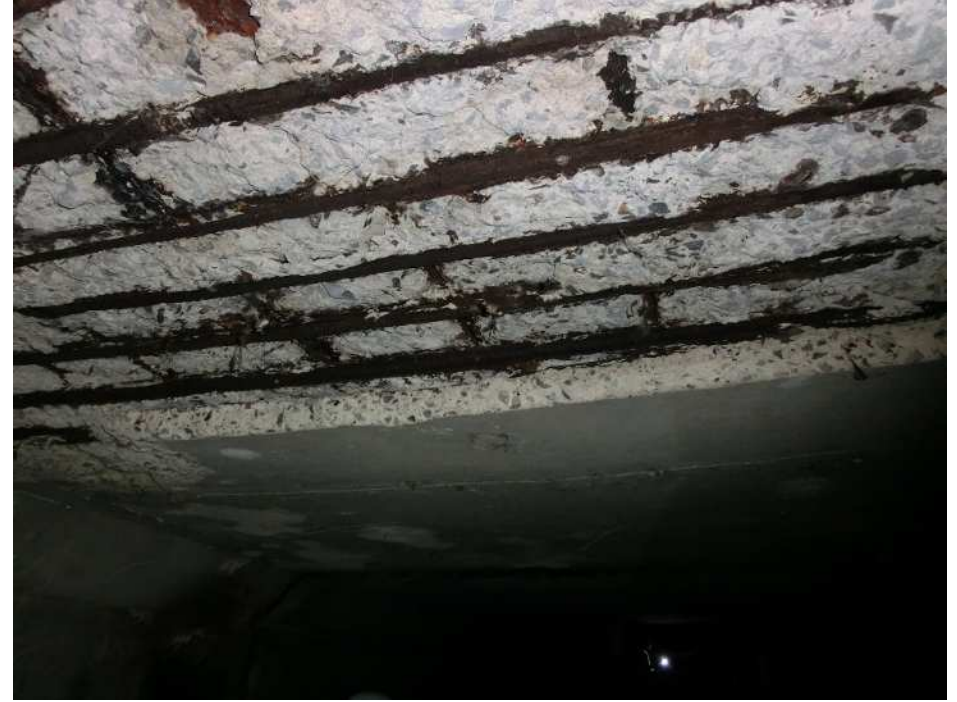
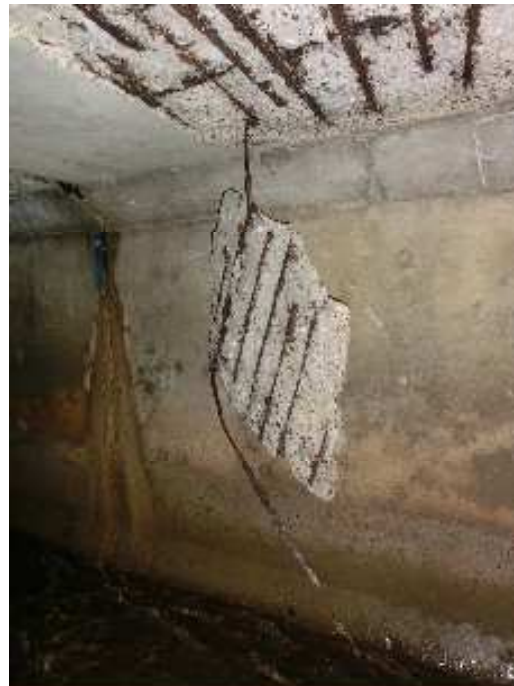
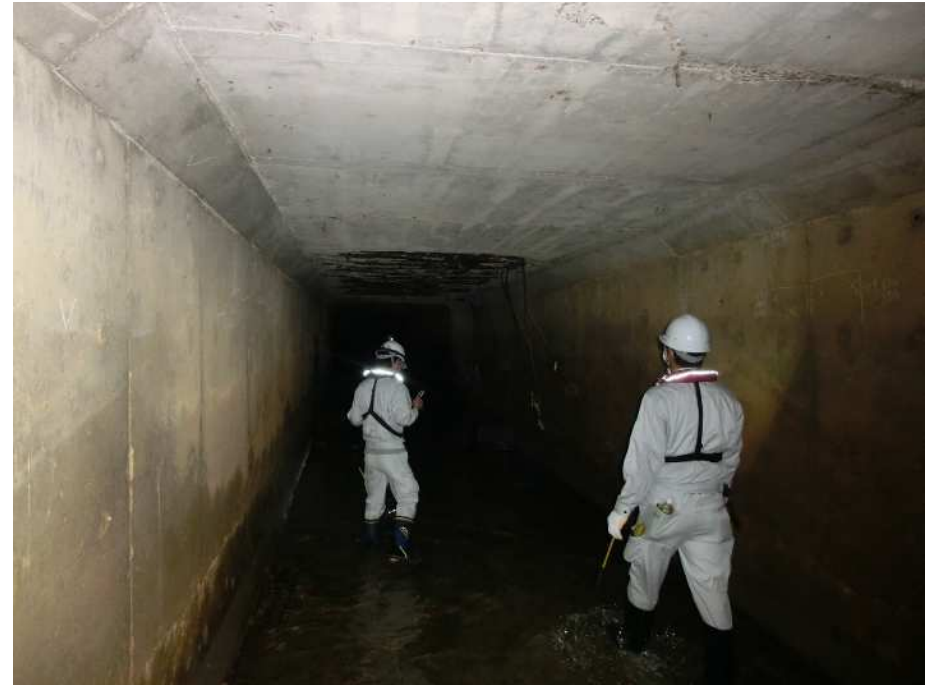
Examples of deterioration seen in inside cast-in-places in Okinawa

- In many cases, the sidewalls are visibly sound, but the lower surface of the top plate has significantly deteriorated.

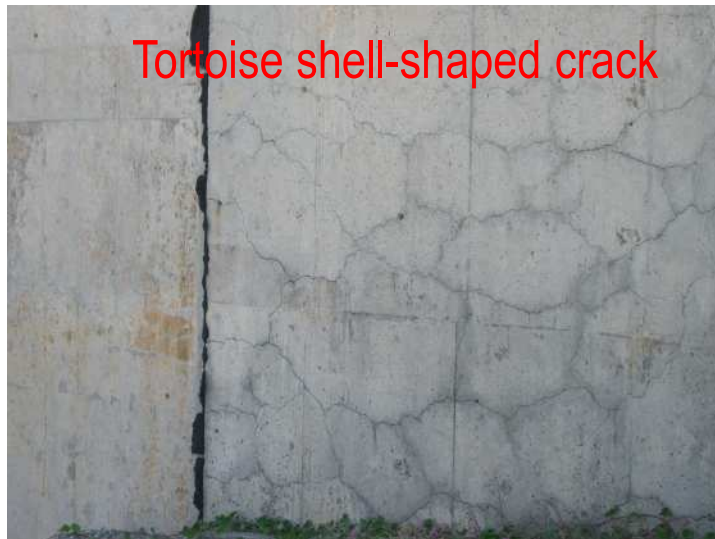
Crack pattern due to ASR deterioration

When the internal binding force is small

When the internal binding force is large

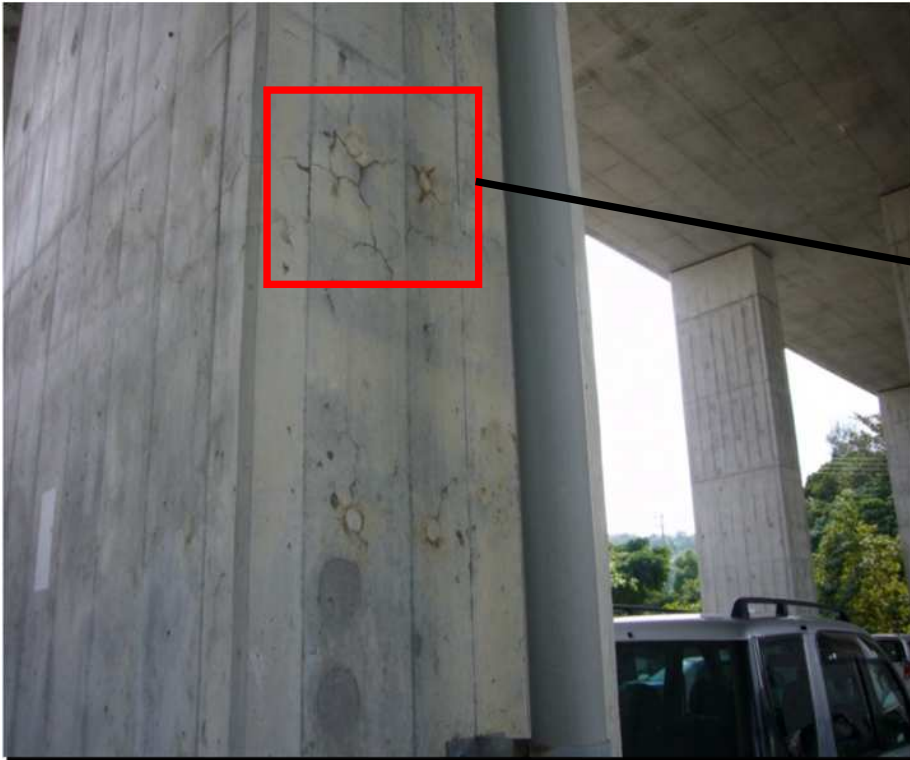
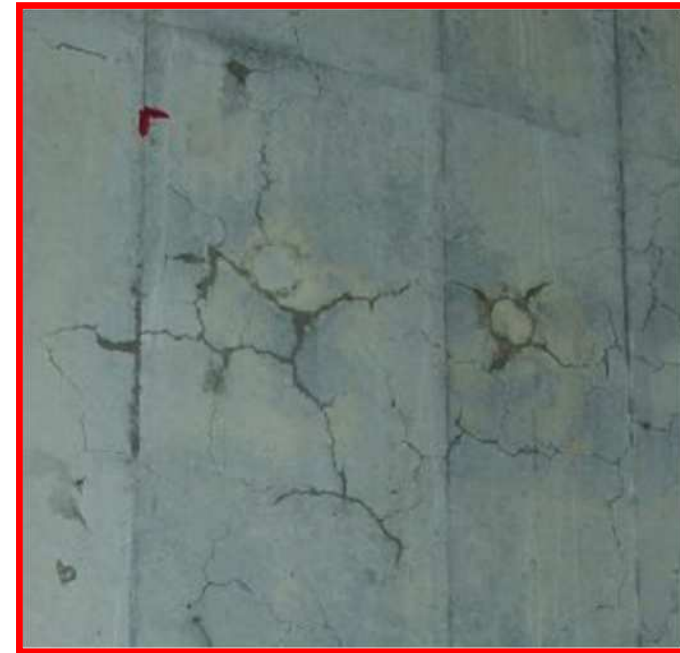
Example of delayed expansion ASR degradation

Viaduct A

Although the degradation is slight and limited and it will necessarily be harmful in the future, in an environment with severe salt damage such as Okinawa Prefecture, there is a concern about the deterioration combined with salt damage.

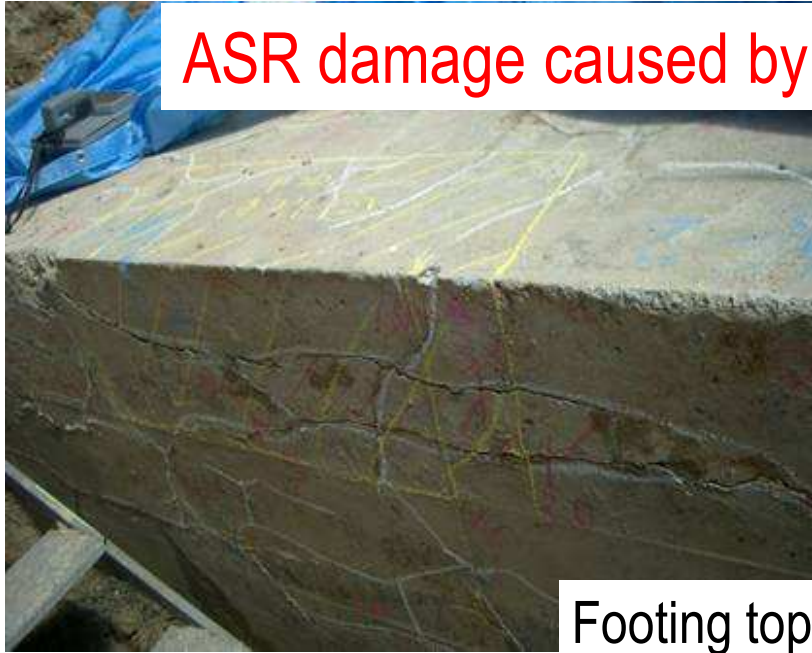
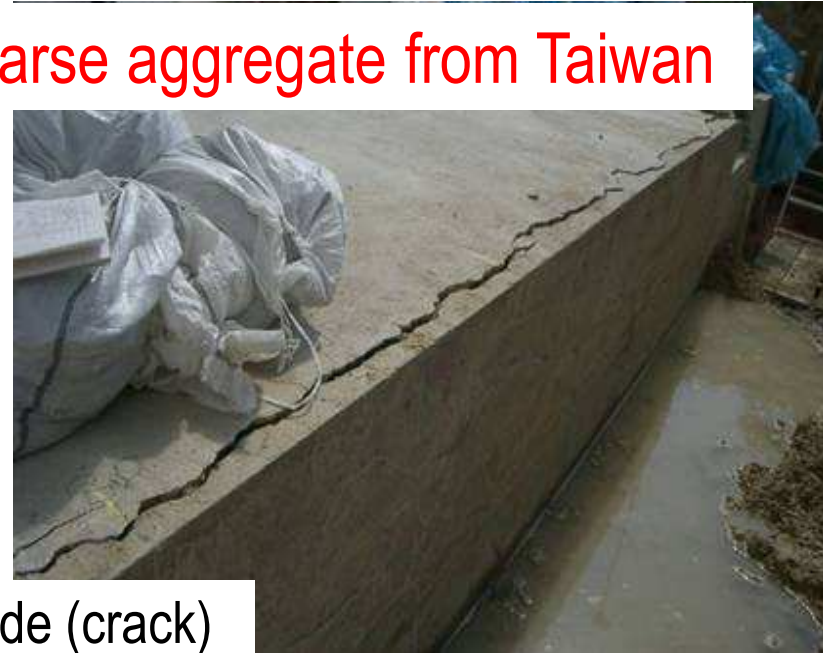
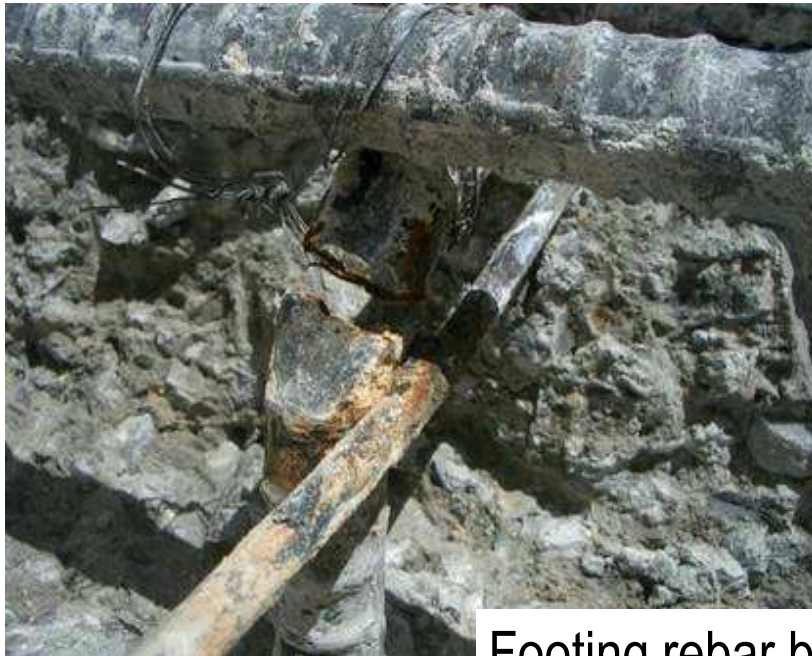
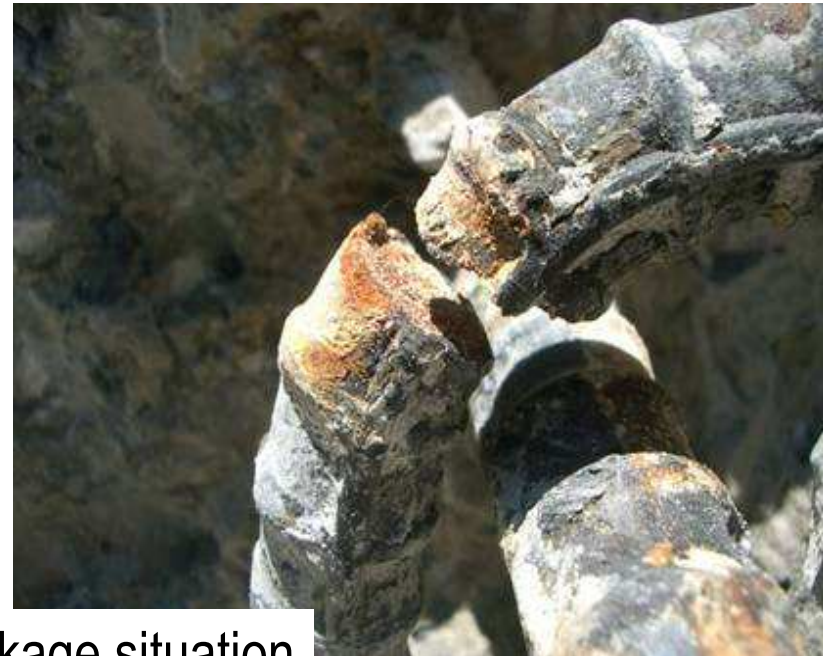
Example of ASR deterioration (Bridge A)

ASR damage caused by coarse aggregate from Taiwan

Footing top / side (crack)

Footing rebar breakage situation

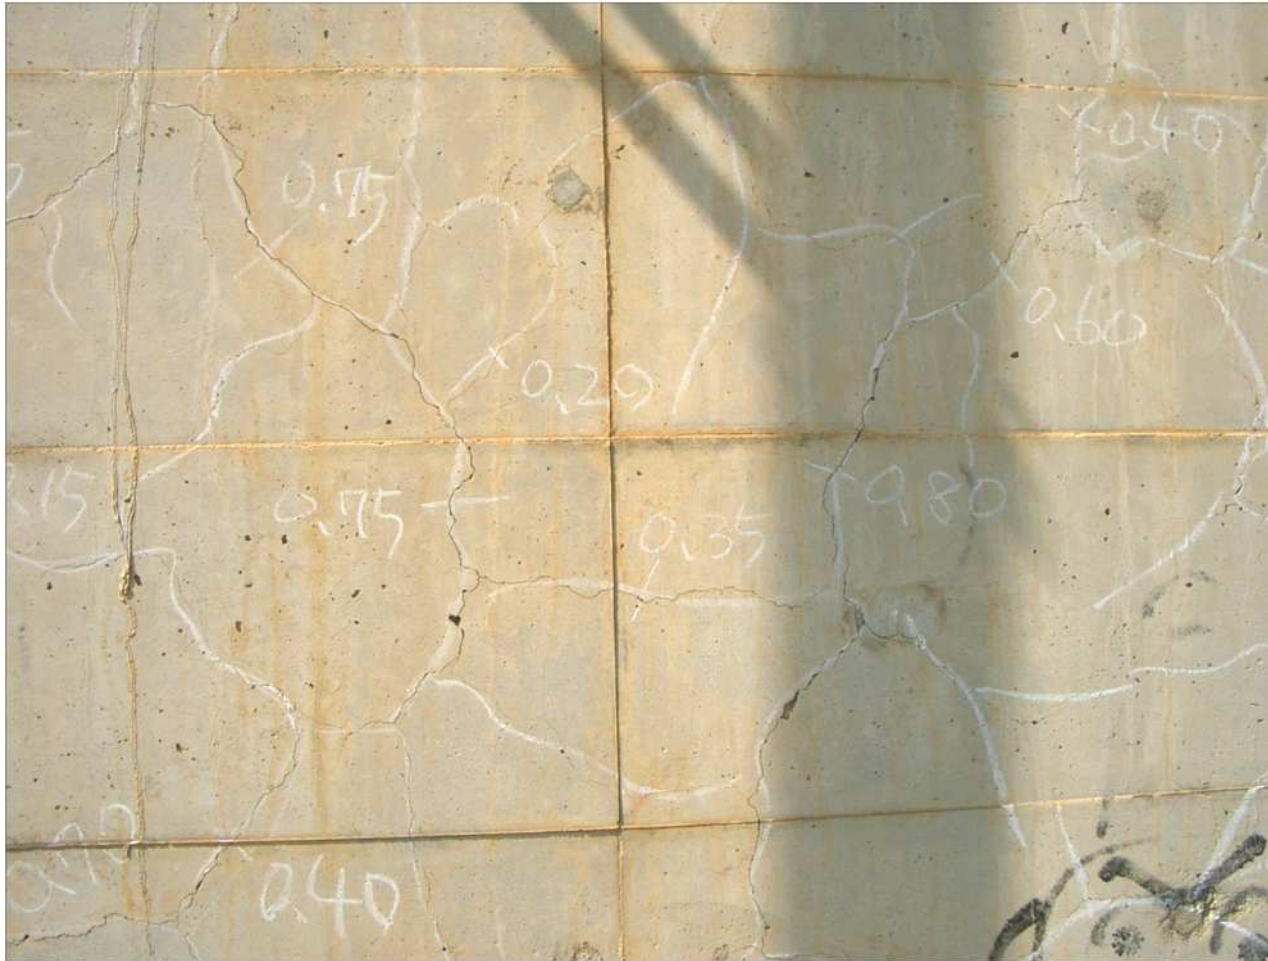
Bridge C

Construction environment: inland area

Completion year: lower 1983, upper 1984

Damage status: **ASR occurred** on the abutment and piers

ASR due to porphyrite
(coarse aggregate) from
Okinawa Prefecture

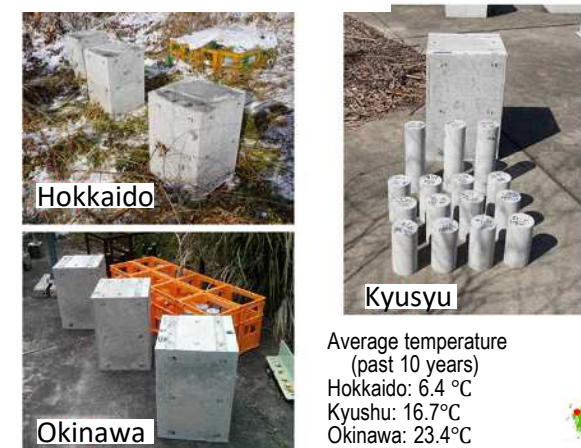
<Method> Exposure status

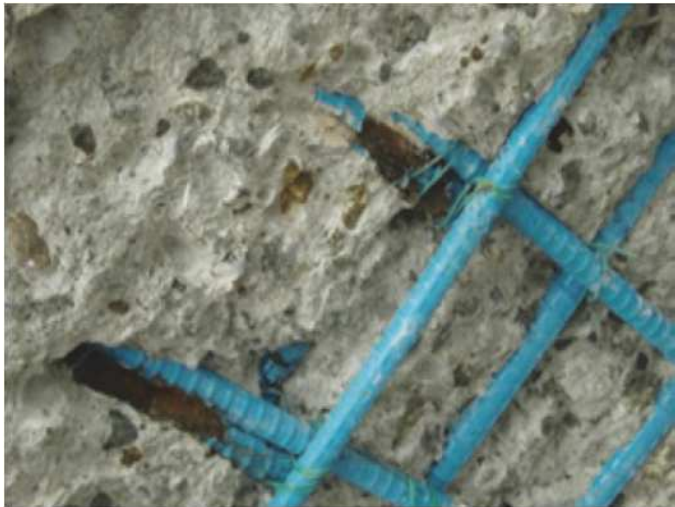
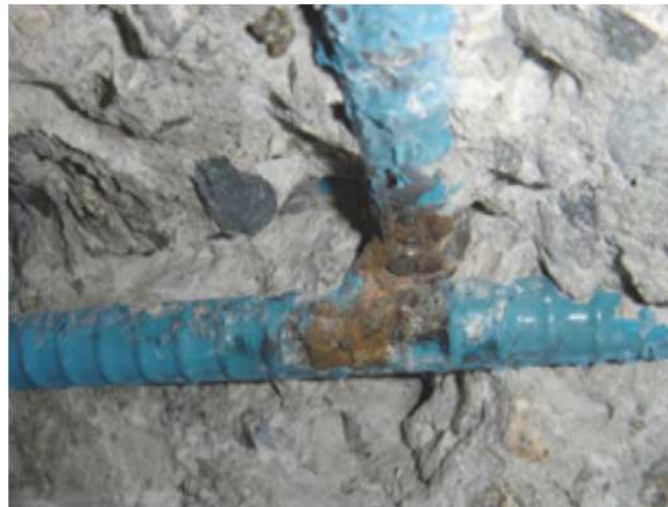
- Ensuring cover is not enough. : Ikema Bridge
- Epoxy coated rebar also corrodes. :

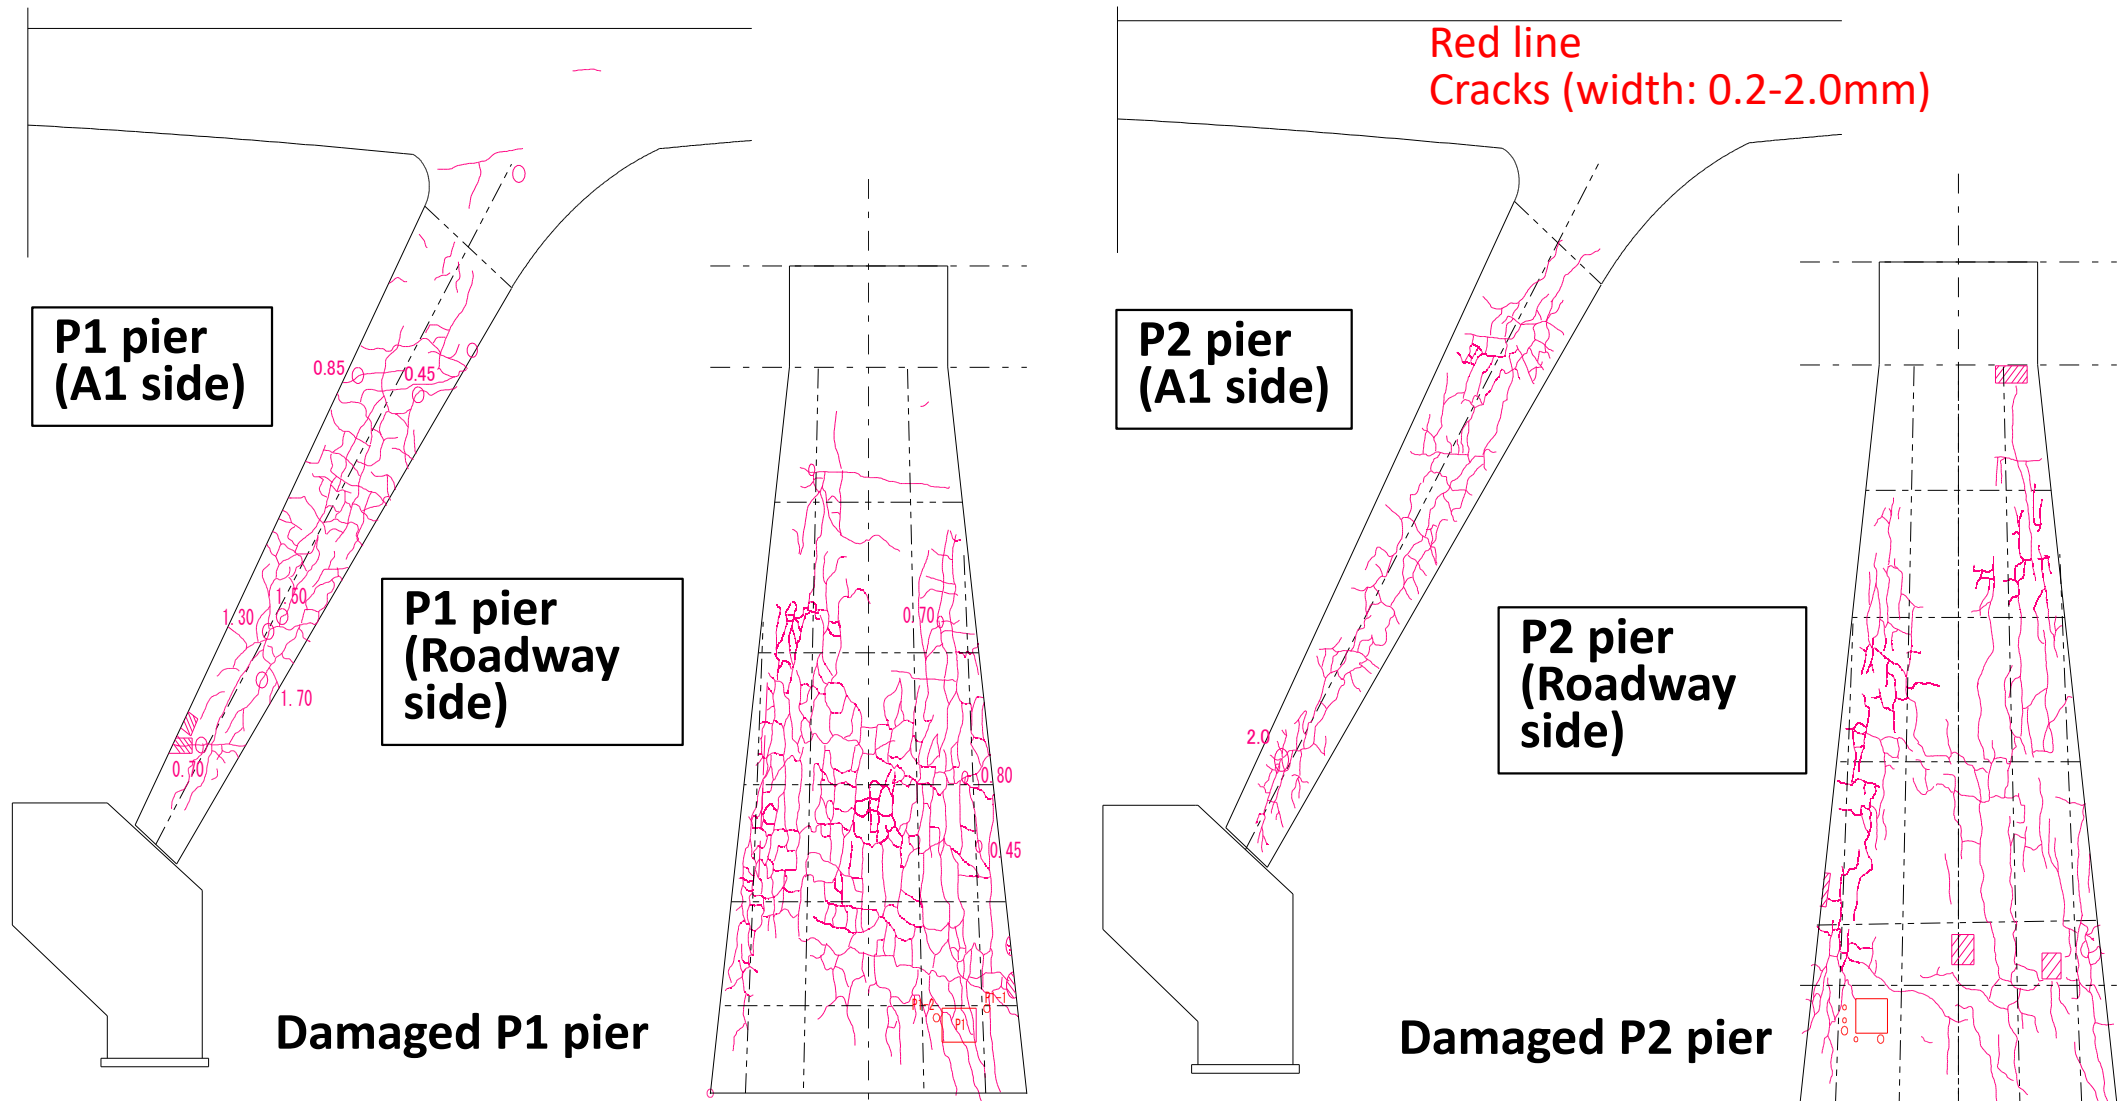
- As a result of the investigation, it was confirmed that tortoiseshell-shaped cracks measuring 0.2mm to 2.0mm in width, believed to be caused by ASR, had occurred throughout both the P1 and P2 piers.
 - It was also confirmed that where the cracks were connected, there was some concrete peeling.
- ⇒ Lithium nitrite is being injected into this structure to confirm its effectiveness.

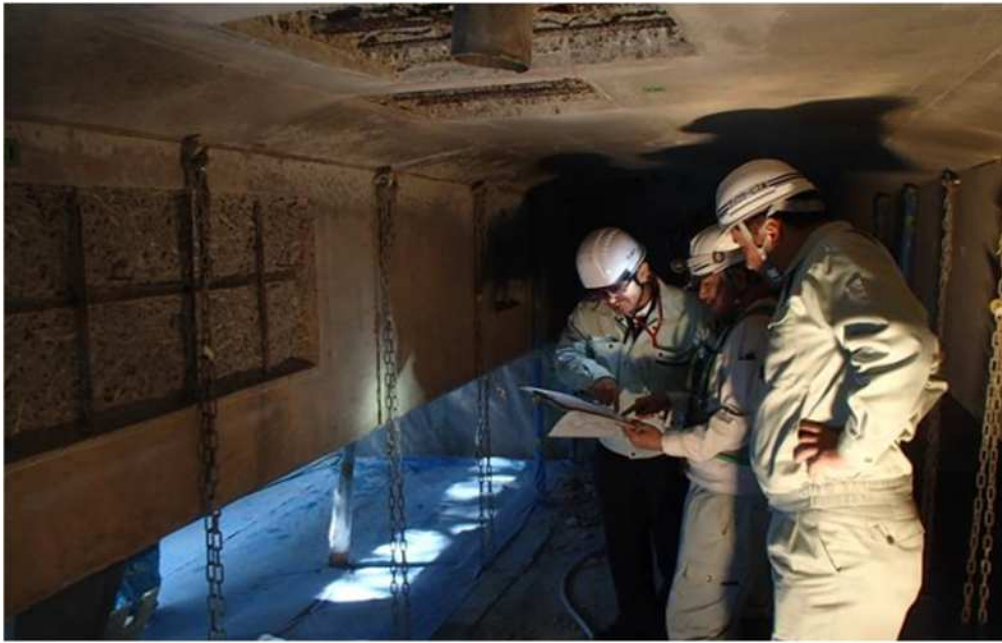
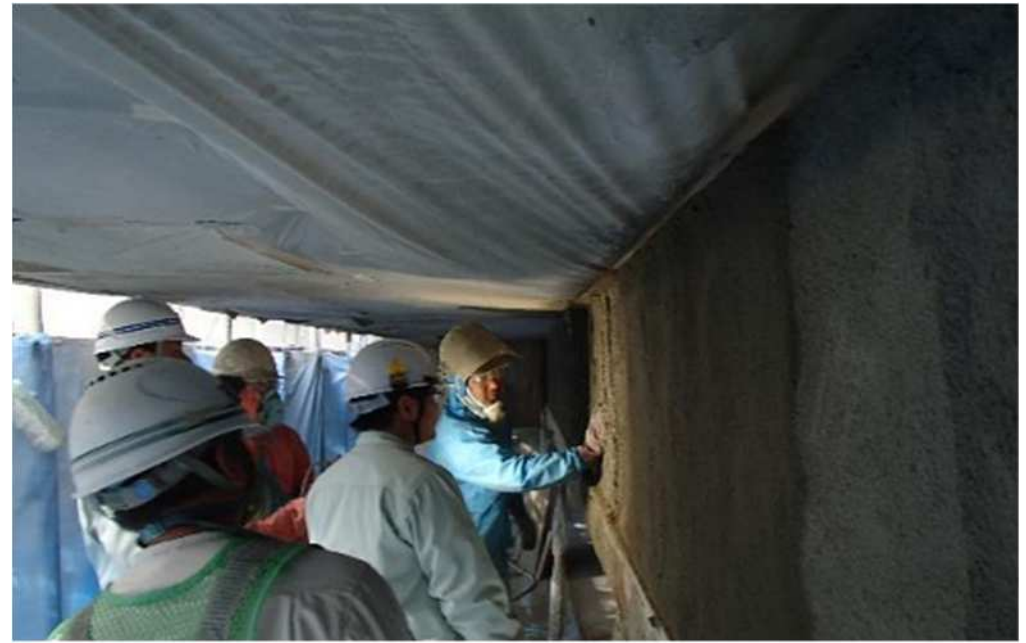
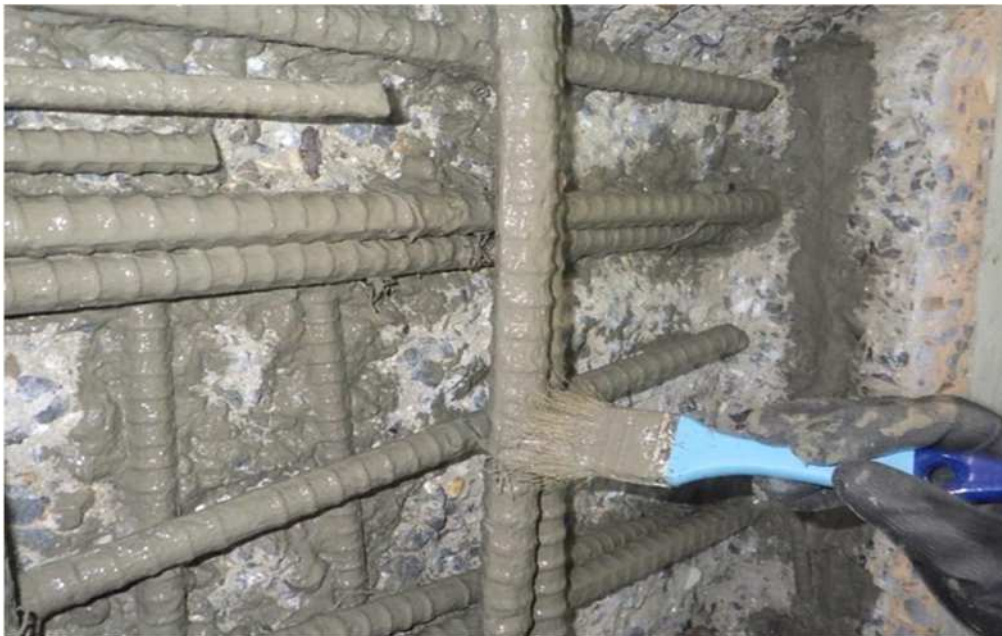
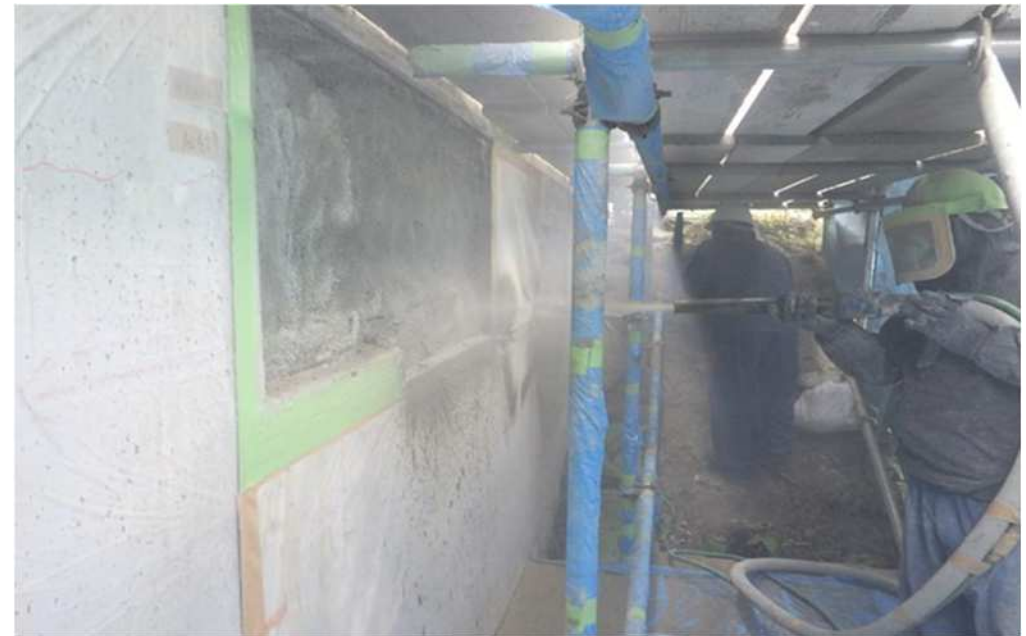
Lithium nitrite-added dry spraying method
