Status of bridge inspection 1

Bridge Repair and Reinforcement Case Studies 1

Bridge Repair and Reinforcement Case Studies 2

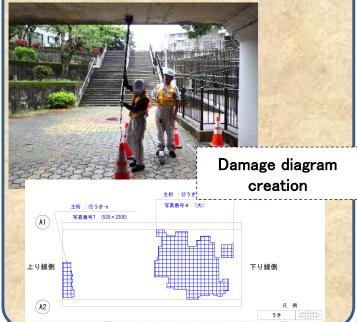
National Route 329 AneBridge (Ogimi Village) Built in 1984

Salt damage caused peeling of the main girder and exposure of reinforcing bars.

Electrical corrosion protection
