# Periodic inspection of road facilities

Okinawa Construction Technology Center

## § 1. bridge inspections

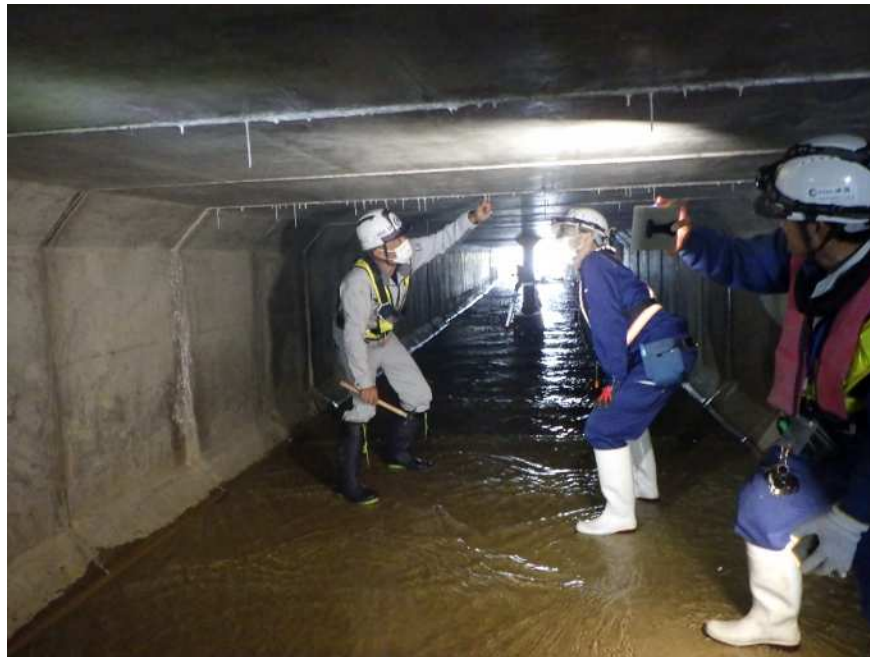
## Inspection method ① [Ground inspection]

When the girder is low (approximately 2m) and can be approached from the ground in a narrow space.

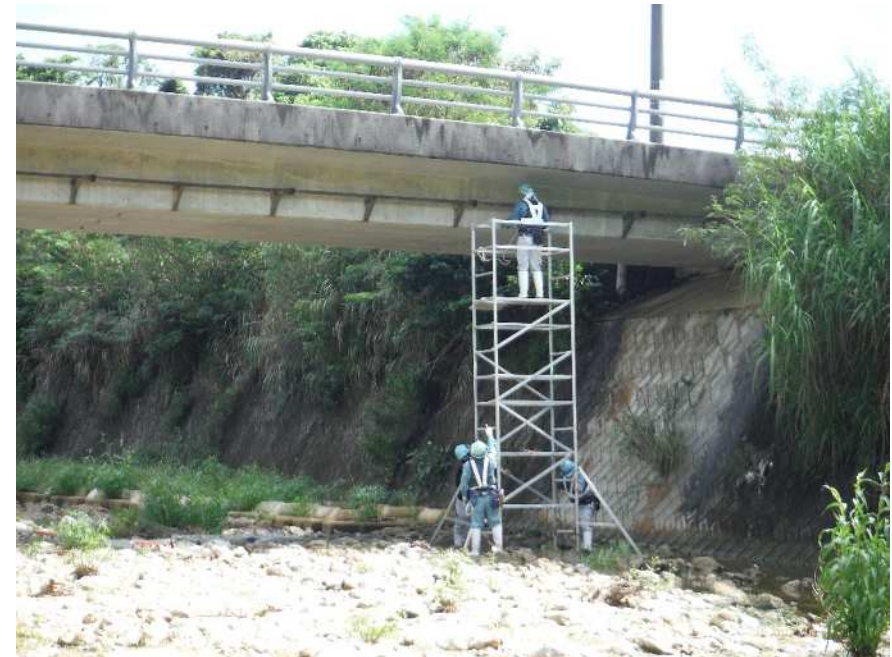
## Inspection method ② [Ladder inspection]

When the height under the girder is relatively low (approx. 4 m) and inspection can be carried out using a ladder or stepladder.

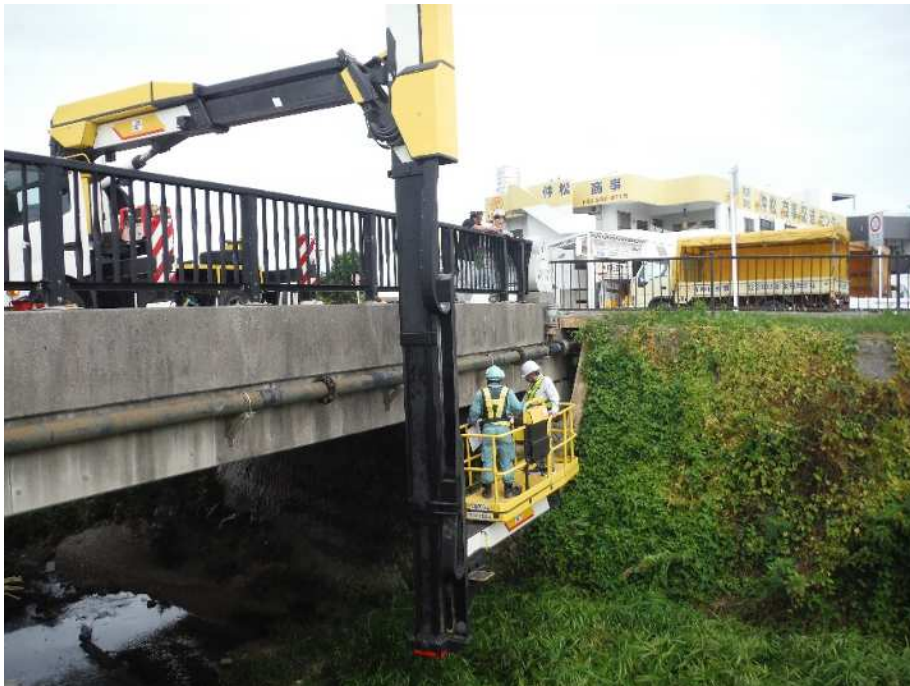
### ③ [Bridge inspection vehicle]

When the height of the girder is too high and it is not possible to enter the girder. Traffic control on the bridge surface is required during inspections. Please note that this may not apply to wide sidewalks or overhead wires, so please be careful.

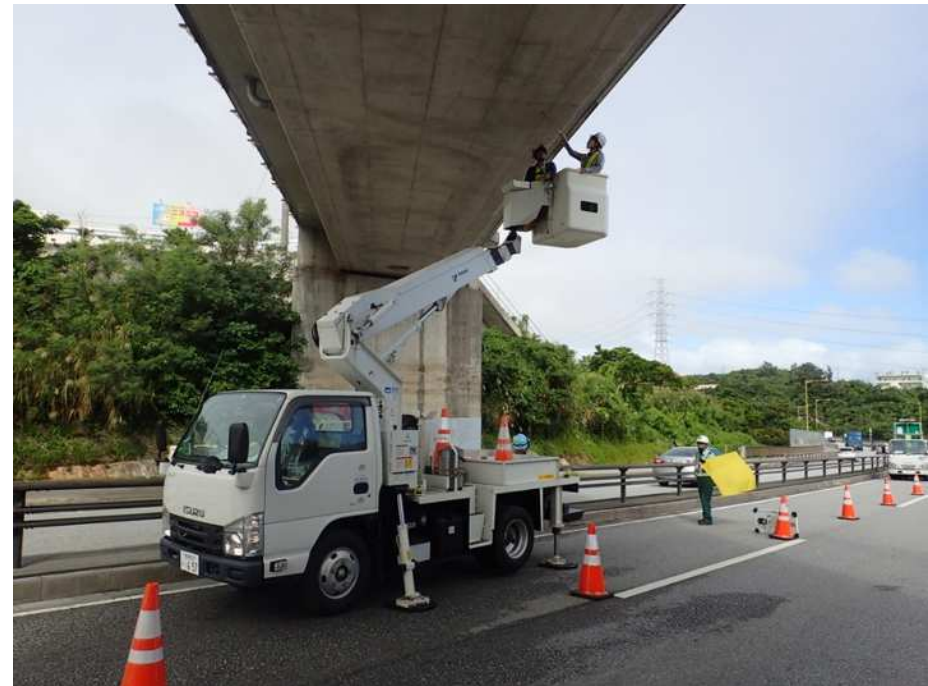
### ④ [Elevating vehicle]

When the height of the girder is high and vehicles can enter under the girder, such as when it intersects with a road. If the area below the bridge is a road, traffic regulations will be required.

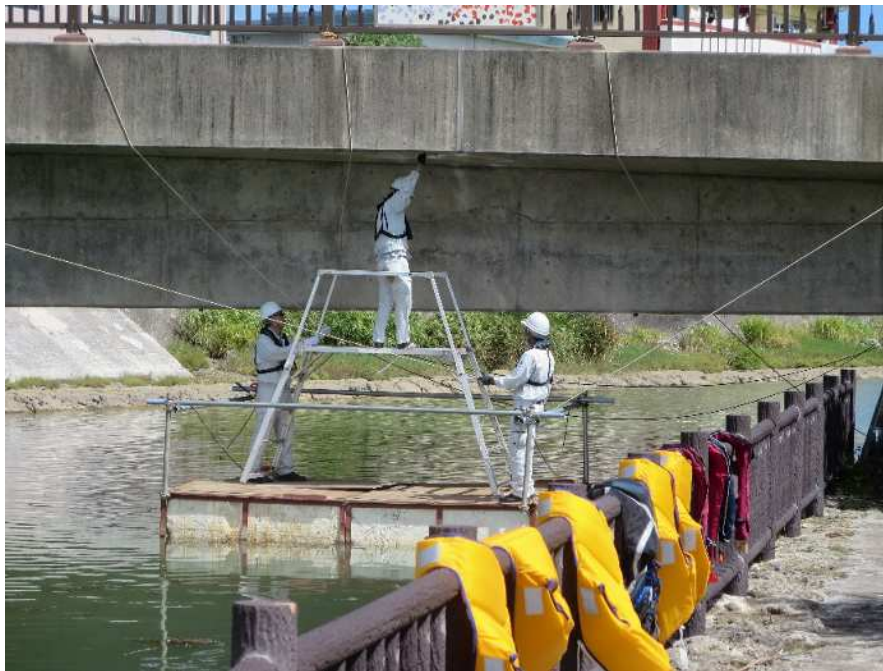
### ⑤ [Barge]

When the area below the girder is in a river or ocean, and the height of the girder is too low for inspection vehicles to enter. Please note that the water level may fluctuate depending on the season or time of day.

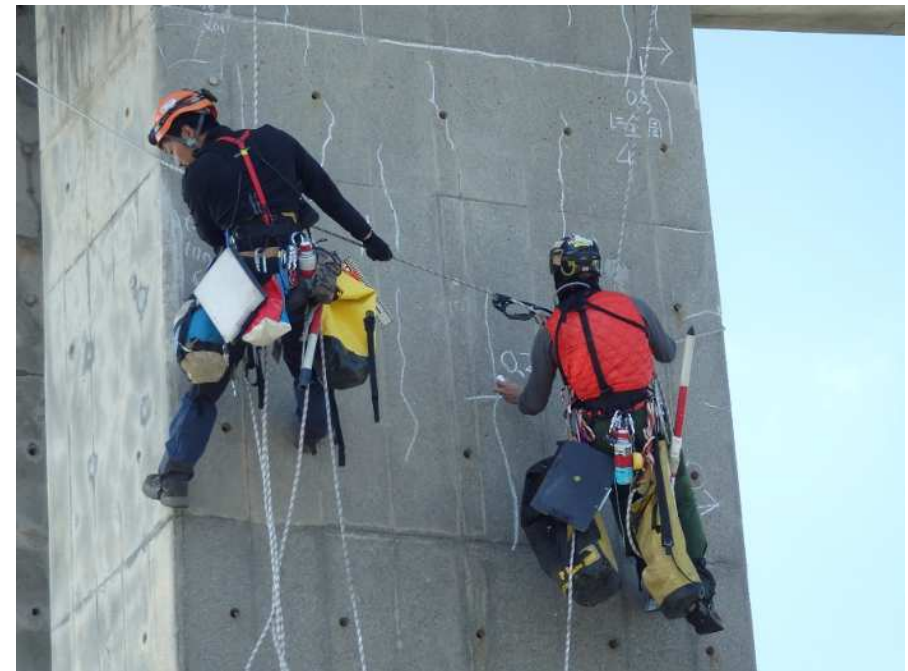
### ⑥ [Others]

Rope access inspections are performed in cases where normal methods are difficult, such as on high bridge piers where inspection vehicles cannot reach from above the bridge surface or below the girder. In recent years, inspections using drones have also been recommended.

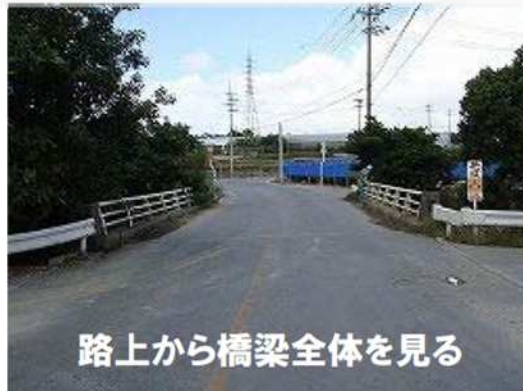
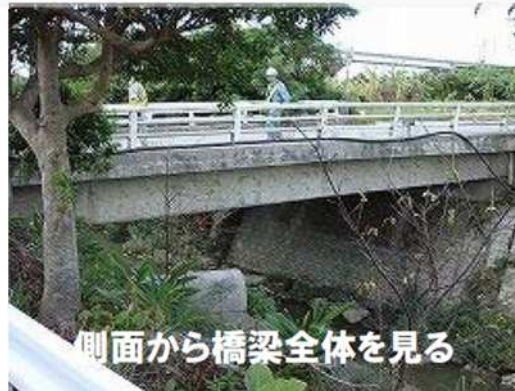
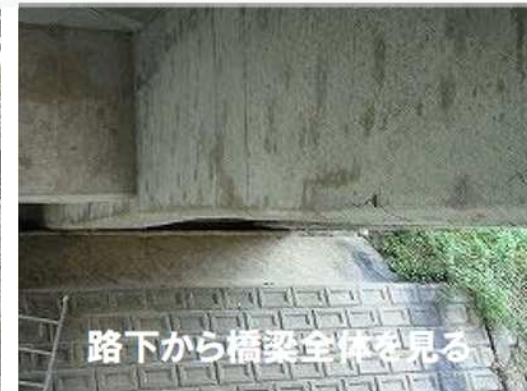
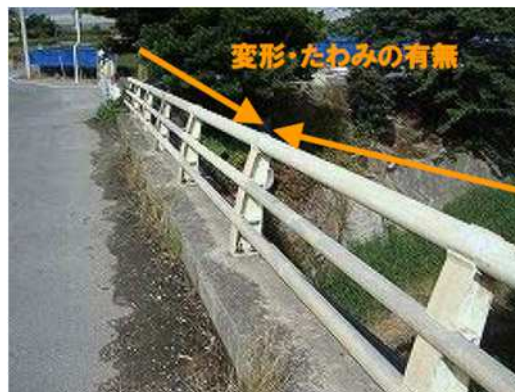
When starting an inspection, observe the entire bridge from the road, side, and under the road to understand the environmental conditions in which the bridge is located, and also check for abnormal noises, vibrations, and abnormal deflections from the overall street. This is effective for understanding deterioration and damage that is difficult to notice from a local perspective.

Deterioration and damage noticed from an overall perspective

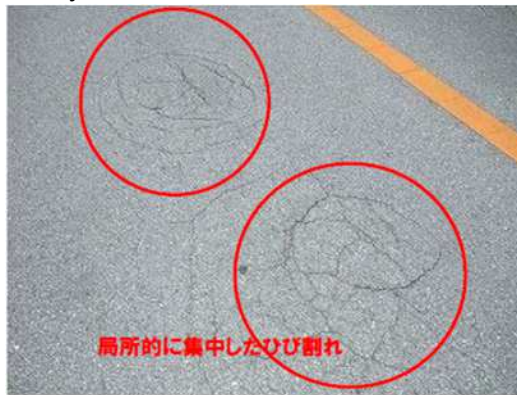
Regarding cracks on the pavement surface, be careful if there are “locally concentrated cracks” or “large cracks in the direction of the bridge axis or in the direction perpendicular to the bridge axis,” as damage to the underside of the deck may occur.

**Examples of cracks on pavement surfaces**

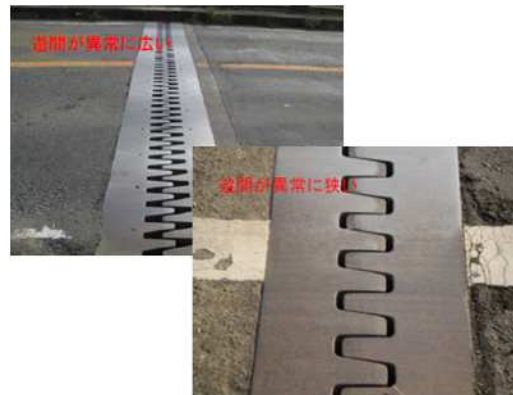
Check for deterioration and damage such as steps and abnormalities in the play space related to the expansion device. If abnormalities in the play space have occurred, the cause may be damage to the bearings and shoes, or movement or tilting of the substructure.

**Examples of anomalies in expansion devices**

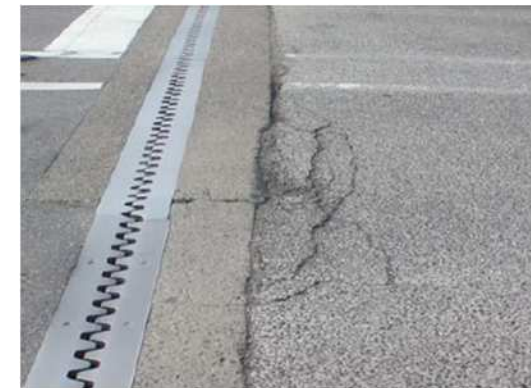
Check for cracks or other deterioration or damage to the pavement behind the abutment. If cracks perpendicular to the bridge axis are present, settlement of the soil behind the abutment may be the cause.

**Example of pavement cracks on back of abutment**

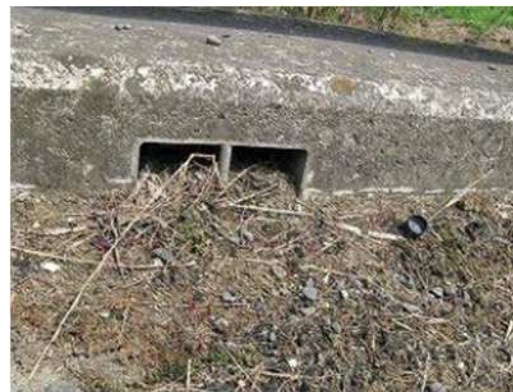
Deterioration of drainage function due to sediment clogging of drainage basins causes water leakage from expansion and contraction devices, etc.

**Example of sediment clogging in drainage basin**

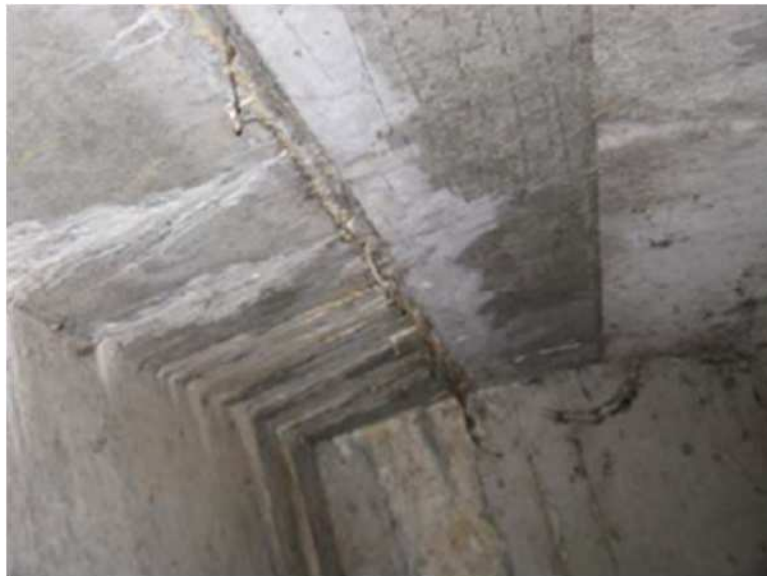
If free lime flows out or leaks from the joints, deterioration may progress. This is thought to be mainly caused by the infiltration of drainage water from the bridge surface, and there is concern that this will accelerate corrosion of the internal steel materials. In addition, if free lime is present, the cracks are deep or penetrating, and there is a high possibility that the internal reinforcing bars are corroded, especially if rust fluid is flowing out or leaking. .

Free lime spillage/leakage from bed slab joints

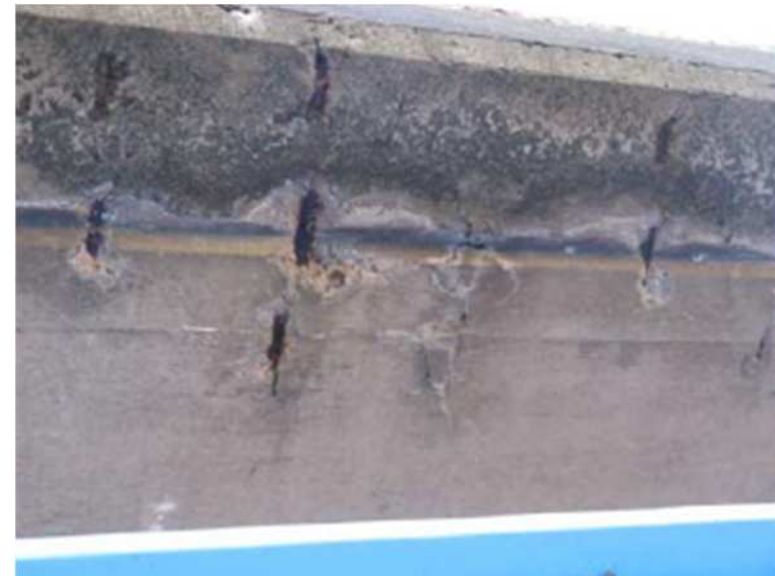
In addition, if there is insufficient cover, carbon dioxide in the air will easily enter the reinforcing bars inside the concrete, causing a phenomenon called carbonation, which will lead to corrosion of the reinforcing bars.

Rebar exposure due to insufficient coverage

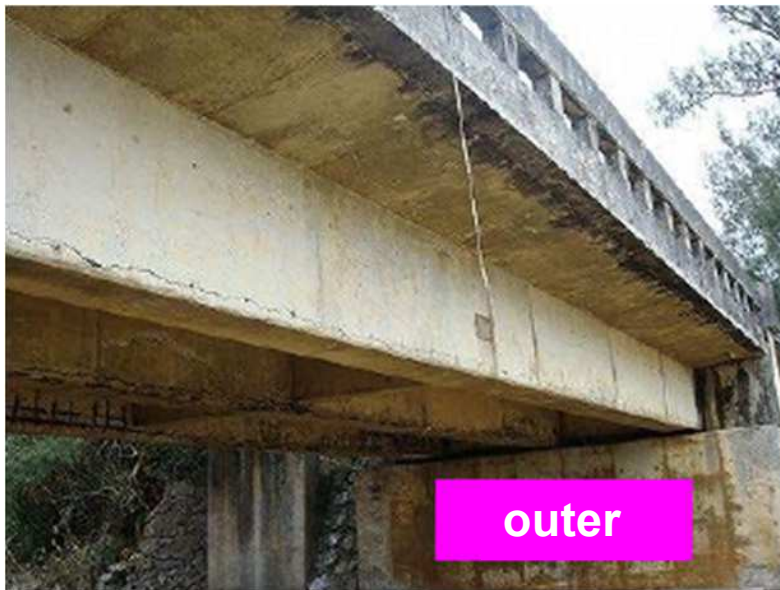
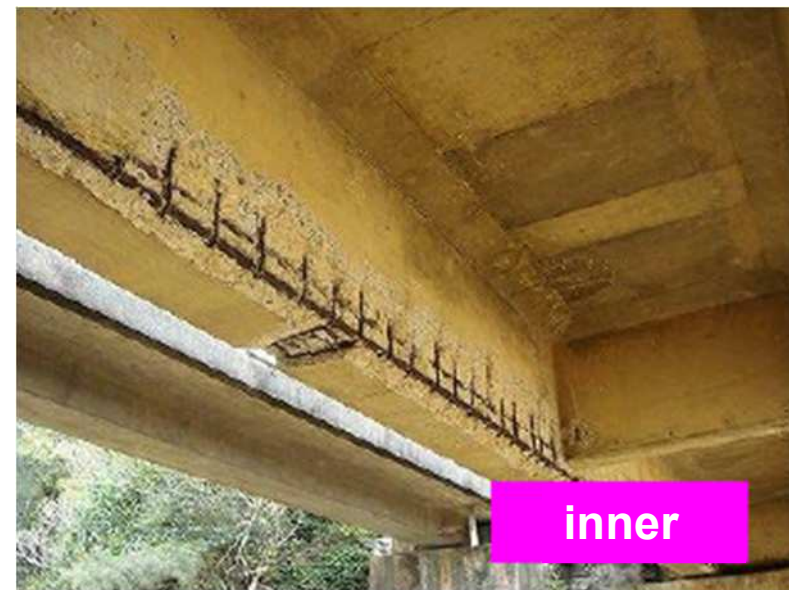
In the case of the main girder, even if airborne salt adheres to the outer surface (outer surface) of the outer girder (the outermost girder), it is washed away by rainwater, etc., so it is relatively unaffected by salt damage, but the inner surface of the outer girder (the outermost girder) (inner surfaces) and inner girders (girders other than the outer girders) tend to retain attached salt and are prone to significant salt damage.

Example of the difference in damage between outer and inner surfaces of an outer girder

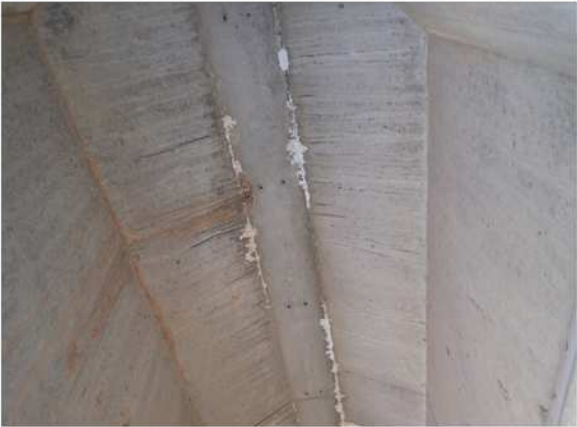
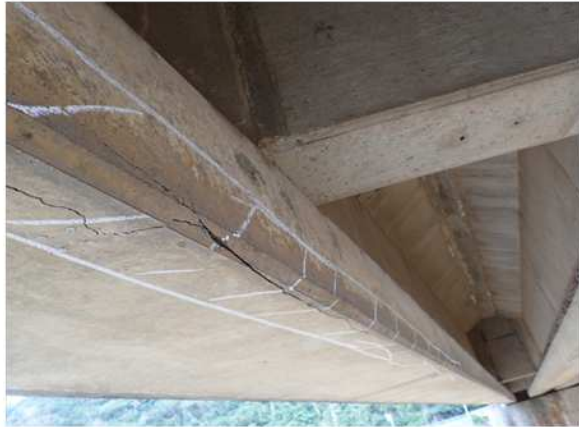
損 傷 写 真	写真番号	25	径間番号	2	撮影年月日	2019/1/23	写真番号	26	径間番号	2	撮影年月日	2019/1/23
	部材名	床版	要素番号	0502	メ モ		部材名	主桁	要素番号	0302	メ モ	
	損傷の種類	漏水・遊離石灰	損傷程度	d	間詰部からの遊離石灰		損傷の種類	うき	損傷程度	e	側面から下面にかけての連続的なうき

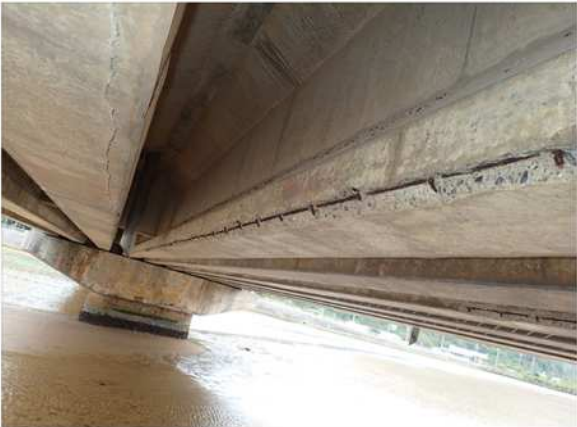
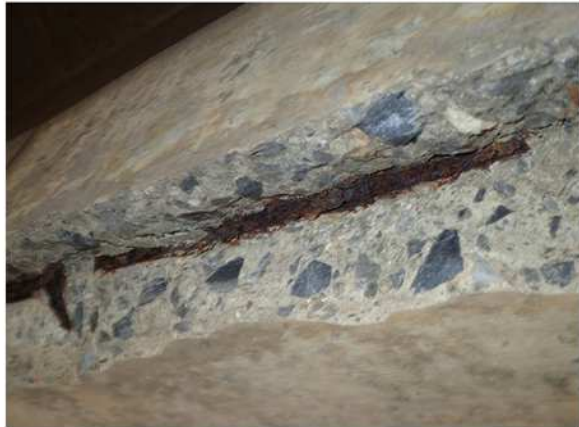
損 傷 写 真	写真番号	27	径間番号	2	撮影年月日	2019/1/23	写真番号	28	径間番号	2	撮影年月日	2019/1/23
	部材名	主桁	要素番号	0603	メ モ		部材名	主桁	要素番号	0603	メ モ	
	損傷の種類	剥離・鉄筋露出	損傷程度	e	側面から下面にかけての連続的な鉄筋露出		損傷の種類	剥離・鉄筋露出	損傷程度	e	写真-27(鉄筋露出)のアップ

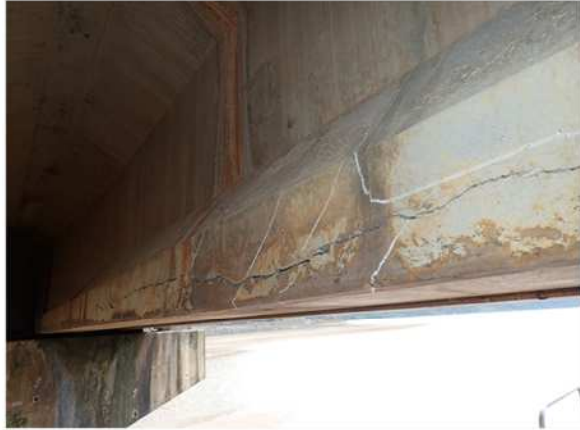
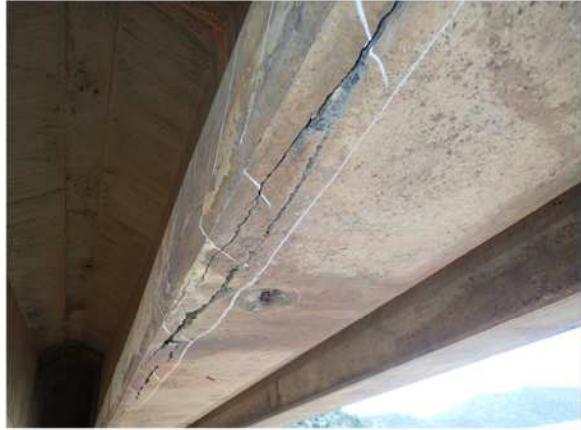
損 傷 写 真	写真番号		17		径間番号		3		撮影年月日		2019/1/23		写真番号		18		径間番号		3		撮影年月日		2019/1/23	
	部材名		主桁		要素番号		0401		メ		モ		部材名		主桁		要素番号		0401		メ		モ	
	損傷の種類		うき		損傷程度		e		側面から下面にかけての連続的なうき(側面状況)				損傷の種類		うき		損傷程度		e		側面から下面にかけての連続的なうき(下面状況)

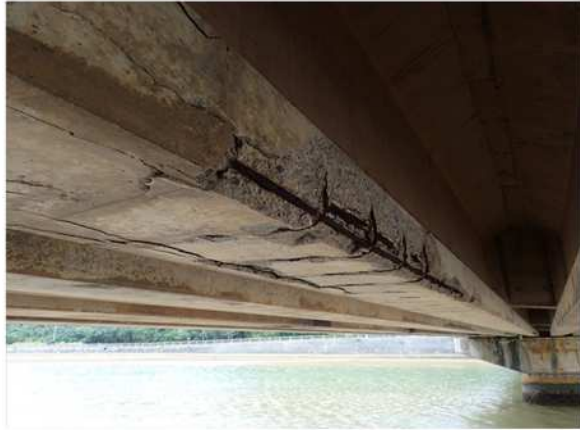
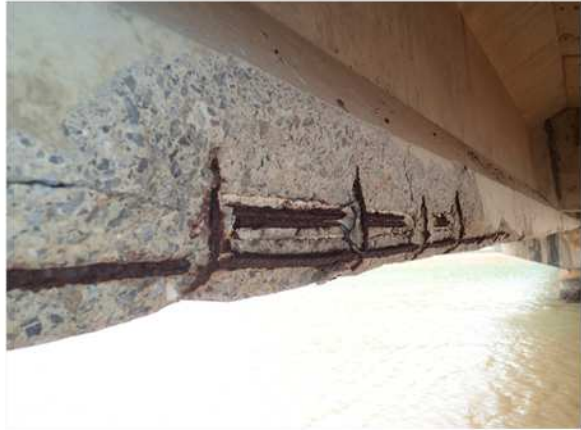
写真番号		19		径間番号		3		撮影年月日		2019/1/23		写真番号		20		径間番号		3		撮影年月日		2019/1/23	
	部材名		主桁		要素番号		0602		メ		モ		部材名		主桁		要素番号		0602		メ		モ	
損傷の種類		剥離・鉄筋露出		損傷程度		e		側面から下面にかけての連続的な鉄筋露出				損傷の種類		剥離・鉄筋露出		損傷程度		e		写真-19(鉄筋露出)の近景

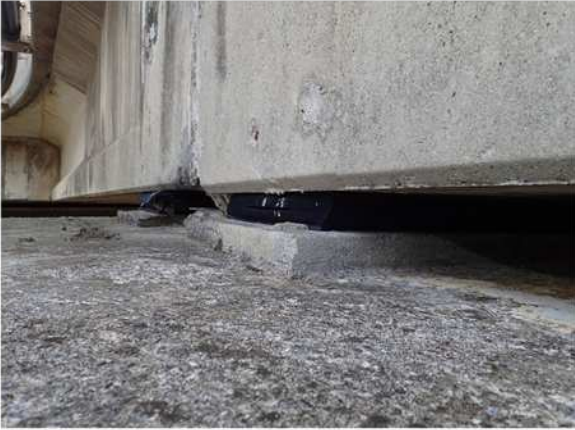
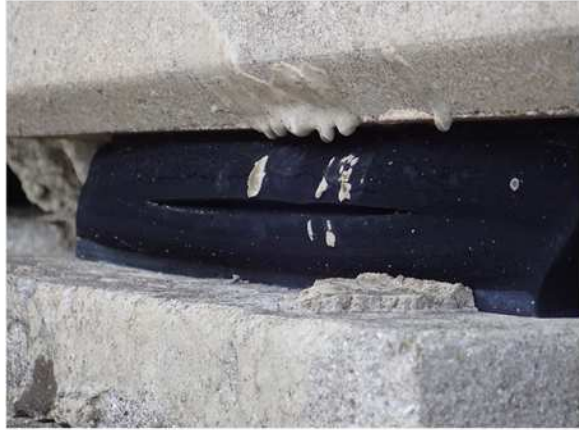
損 傷 写 真	写真番号	61	径間番号	2	撮影年月日	2019/1/23	写真番号	62	径間番号	2	撮影年月日	2019/1/23
	部材名	支承本体	要素番号	1201	メ モ		部材名	支承本体	要素番号	1201	メ モ	
	損傷の種類	変色・劣化	損傷程度	e	ゴムの劣化		損傷の種類	変色・劣化	損傷程度	e	写真-61(ゴムの劣化)のアップ

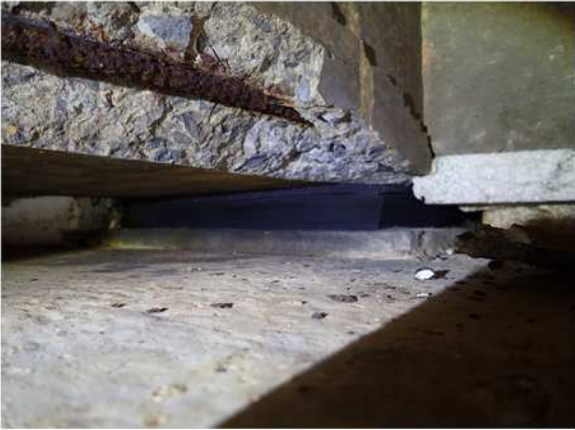
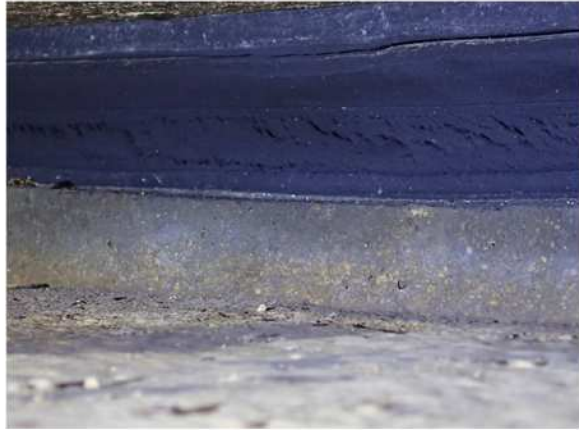
損 傷 写 真	写真番号	63	径間番号	2	撮影年月日	2019/1/23	写真番号	64	径間番号	2	撮影年月日	2019/1/23
	部材名	支承本体	要素番号	1001	メ モ		部材名	支承本体	要素番号	1001	メ モ	
	損傷の種類	変色・劣化	損傷程度	e	ゴムの劣化		損傷の種類	変色・劣化	損傷程度	e	写真-63(ゴムの劣化)のアップ

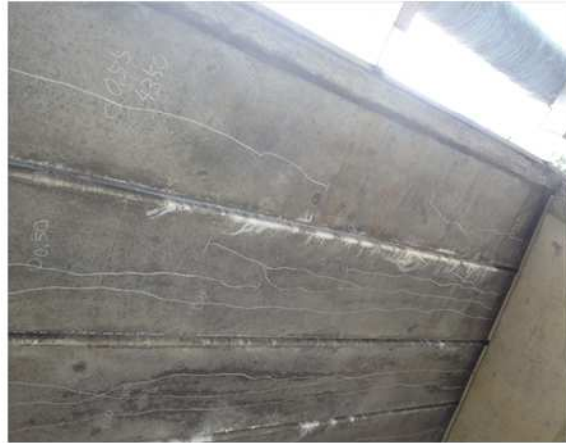
点検調査(その6) 損傷写真				径間番号		2		起点側		緯度		経度		終点側		緯度		経度		橋梁ID		26.62542-128.00197			
フリガナ 橋梁名				路線名				管轄		沖縄県土木建築部				橋梁コード											
所在地		自		距離標		自				0.7kp + 19m		維持管理班				調書更新年月日		2019年3月29日							
		至				至				0.7kp + 35m															
写真番号		33		径間番号		2		撮影年月日		2018/10/23		写真番号		34		径間番号		2		撮影年月日		2018/10/23			
部材名		主桁		要素番号		0401		メ		モ		部材名		床版		要素番号		0301		メ		モ			
損傷の種類		ひびわれ		損傷程度		d		写真-32(ひびわれ)のアップ (計測)				損傷の種類		漏水・遊離石灰		損傷程度		d		床版間詰め部から滲出した遊離石灰 (桁端部付近)					
損傷写真		 										 													
		写真番号		35		径間番号		2		撮影年月日		2018/10/23		写真番号		36		径間番号		2		撮影年月日		2018/10/23	
		部材名		床版		要素番号		0301		メ		モ		部材名		床版		要素番号		0101		メ		モ	
損傷の種類		漏水・遊離石灰		損傷程度		d		写真-34(遊離石灰)のアップ				損傷の種類		漏水・遊離石灰		損傷程度		d		床版間詰め部から滲出した遊離石灰 (桁端部付近)

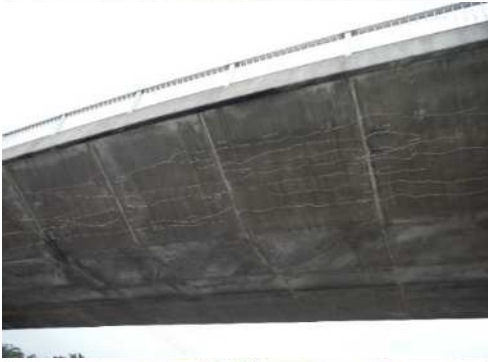
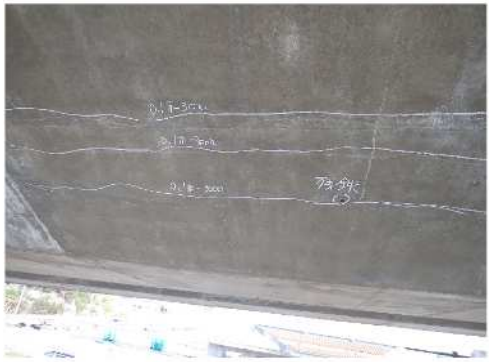
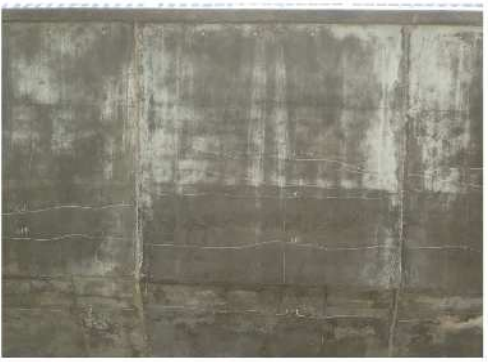
損 傷 写 真	写真番号	1	径間番号	10	写真番号	2	径間番号	10	写真番号	3	径間番号	10
	部材名	主桁	要素番号	0101	部材名	主桁	要素番号	0101	部材名	主桁	要素番号	0101
	損傷の種類	ひびわれ	損傷程度	c	損傷の種類	ひびわれ, その他(残鉄)	損傷程度	c,e	損傷の種類	ひびわれ	損傷程度	c

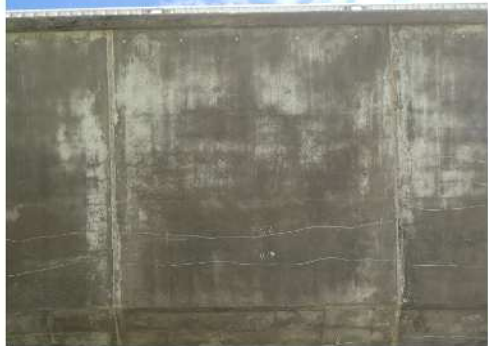
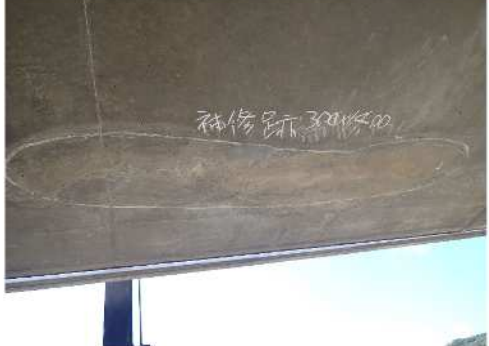
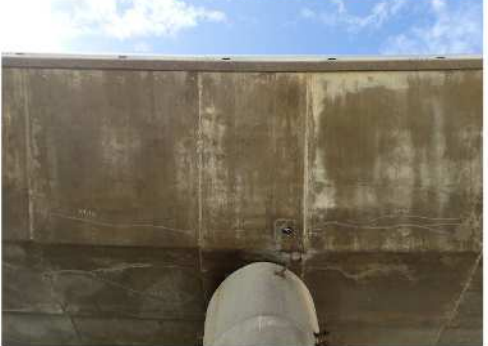
前回損傷程度
				c				c,e				-
				メモ				メモ				メモ
				(パターン23)				ひびわれ (パターン23)				(パターン23)
	写真番号	4	径間番号	10	写真番号	5	径間番号	10	写真番号	6	径間番号	10
	部材名	主桁	要素番号	0101	部材名	主桁	要素番号	0101	部材名	主桁	要素番号	0101
	損傷の種類	ひびわれ	損傷程度	c	損傷の種類	その他(修復跡)	損傷程度	e	損傷の種類	ひびわれ	損傷程度	b

前回損傷程度
				-				e				b
				メモ				メモ				メモ
				(パターン23)				1400×300				0.1末-4300 (パターン23)

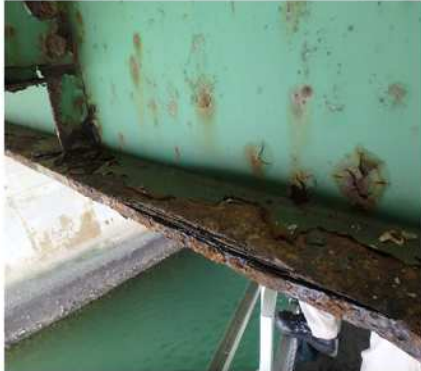
点検調書(その6) 損傷写真				径間番号	1	起点側	緯度		終点側	緯度		橋梁ID	—
							経度			経度			
フリガナ 橋 梁 名				路 線 名				沖 縄 県			橋 梁 コー ド	—	
所 在 地	自				距 離 標	自	17.9 km + 0 m		管 轄		調書更新年月日	平成31年3月31日	
	至					至	17.9 km + 0 m			維持管理班	最新点検年月日	平成30年9月20日	
損 傷 写 真	写真番号	25	径間番号	1	撮影年月日	平成30年9月20日		写真番号	26	径間番号	1	撮影年月日	平成30年9月20日
	部材名	主桁	要素番号	0106	メ モ		部材名	主桁	要素番号	0205	メ モ		
	損傷の種類	腐食	損傷程度	d	桁端部に著しい腐食が見られる。		損傷の種類	腐食	損傷程度	d	主桁下フランジに著しい腐食および垂直補剛材と下フランジ溶接部の破断が見られる。

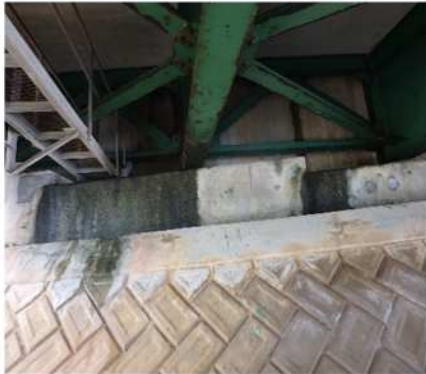
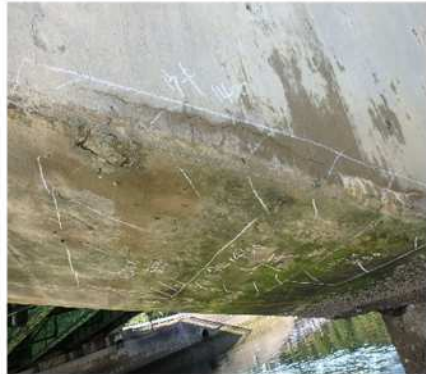
点検調書(その6) 損傷写真				径間番号	1	起点側	緯度		終点側	緯度		橋梁ID	—
							経度			経度			
フリガナ 橋 梁 名				路 線 名				沖 縄 県			橋 梁 コー ド	—	
所 在 地	自				距 離 標	自	17.9 km + 0 m		管 轄		調 書 更 新 年 月 日	平成31年3月31日	
	至					至	17.9 km + 0 m			維 持 管 理 班	最 新 点 検 年 月 日	平成30年9月20日	
損 傷 写 真	写真番号	65	径間番号	1	撮影年月日	平成30年9月20日		写真番号	66	径間番号	1	撮影年月日	平成30年9月20日
	部材名	縦壁	要素番号	0101	メ モ		部材名	梁部	要素番号	0102	メ モ		
	損傷の種類	漏水・滞水	損傷程度	e	縦壁に伸縮装置からの漏水が見られる。		損傷の種類	うき	損傷程度	e	梁部下面にうき[550mm×1200mm,450mm×900mm,350mm×600mm]が見られる。

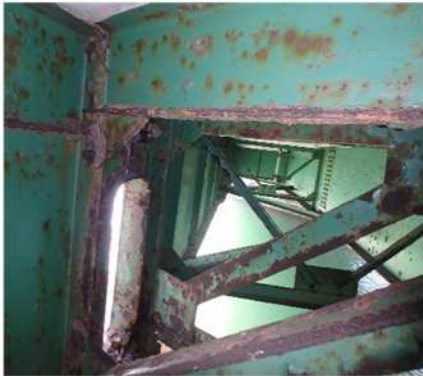
点検調書(その6) 損傷写真				径間番号	1		起点側	緯度		終点側	緯度		橋梁ID	—				
								経度			経度							
フリガナ 橋 梁 名					路 線 名					沖縄県		橋梁コード		—				
所 在 地		自				距 離 標	自	17.9 km + 0 m		管 轄			調書更新年月日	平成31年3月31日				
		至					至	17.9 km + 0 m			維持管理班		最新点検年月日	平成30年9月20日				
損 傷 写 真	写真番号	41		径間番号	1		撮影年月日	平成30年9月20日		写真番号	42		径間番号	1		撮影年月日	平成30年9月20日	
	部材名	対傾構		要素番号	0107		メ モ			部材名	対傾構		要素番号	0107		メ モ		
	損傷の種類	腐食		損傷程度	d		対傾構に腐食が見られる。			損傷の種類	腐食		損傷程度	d		写真41の接写。

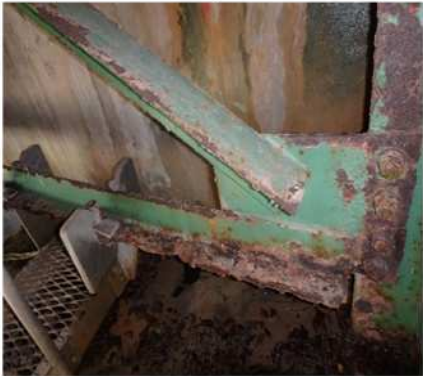
写真番号	43		径間番号	1		撮影年月日	平成30年9月20日		写真番号	44		径間番号	1		撮影年月日	平成30年9月20日	
	部材名	対傾構		要素番号	0401		メ モ			部材名	対傾構		要素番号	0401		メ モ		
損傷の種類	腐食		損傷程度	e		対傾構に著しい腐食および断面欠損 [30mm×1100mm]が見られる。			損傷の種類	変形・欠損		損傷程度	c		写真43の断面欠損部の接写。

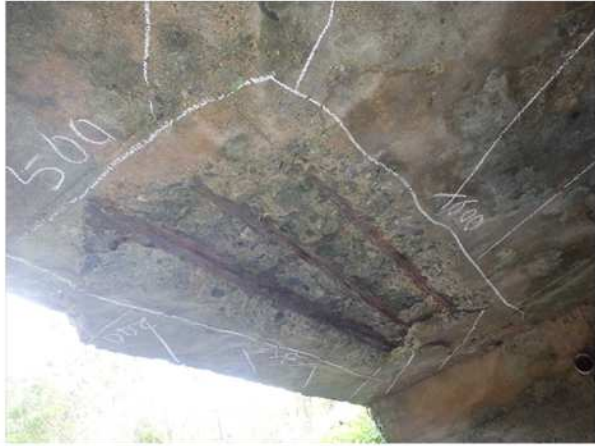
損 傷 写 真	写真番号	1	径間番号	1-4	撮影年月日	2018/10/23	写真番号	2	径間番号	1-4	撮影年月日	2018/10/23
	部材名	主桁	要素番号	0101	メ モ		部材名	主桁	要素番号	0101	メ モ	
	損傷の種類	剥離・鉄筋露出	損傷程度	e	呑口側の剥離・鉄筋露出 1600×500mm		損傷の種類	剥離・鉄筋露出	損傷程度	e	写真-1(鉄筋露出)のアップ ※鉄筋の腐食が著しく、破断寸前の状態である。

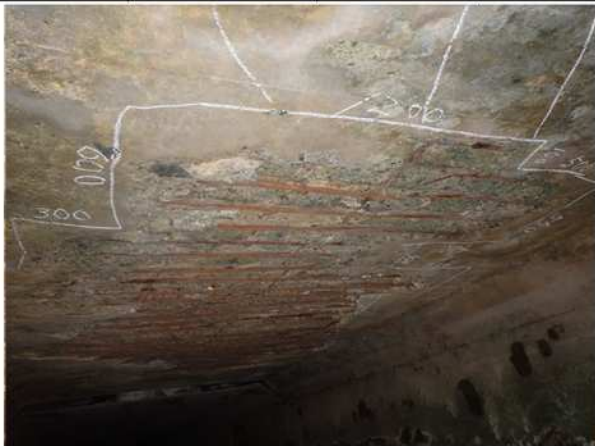
損 傷 写 真	写真番号	3	径間番号	1-4	撮影年月日	2018/10/23	写真番号	4	径間番号	1-4	撮影年月日	2018/10/23
	部材名	主桁	要素番号	0101	メ モ		部材名	主桁	要素番号	0101	メ モ	
	損傷の種類	剥離・鉄筋露出	損傷程度	e	呑口側の広範囲な鉄筋露出 (呑口側⇒吐口側を撮影) ※鉄筋露出部の周囲は全体的に⑫うき(e)が生じている。		損傷の種類	剥離・鉄筋露出	損傷程度	e	呑口側の広範囲な鉄筋露出 (吐口側⇒呑口側を撮影) ※鉄筋露出部の周囲は全体的に⑫うき(e)が生じている。

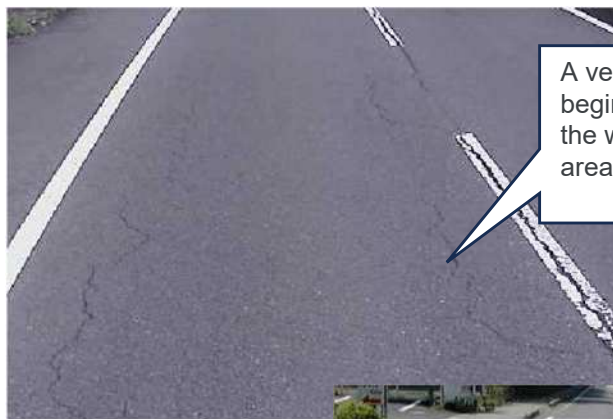
Example of cracks (early stage)

- It develops from the bottom of the asphalt mixture layer upwards
- Initially, one crack appears vertically on each side of the wheel passage
- If the crack penetrates through the pavement, fine particles in the roadbed material are ejected
- Ejection marks are easily visible immediately after the road surface dries after rain

A vertical crack begins to appear in the wheel passage area

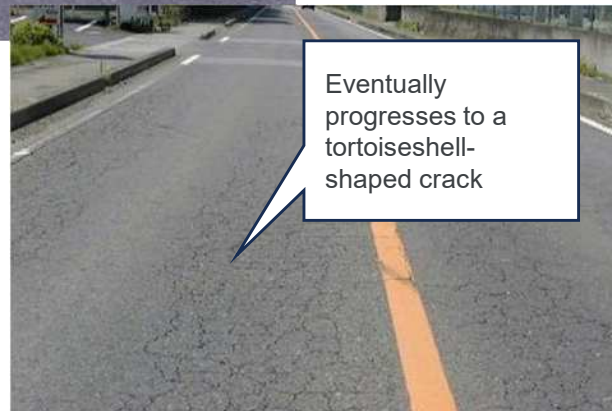
Example of cracks (final stage)

Eventually progresses to a tortoiseshell-shaped crack

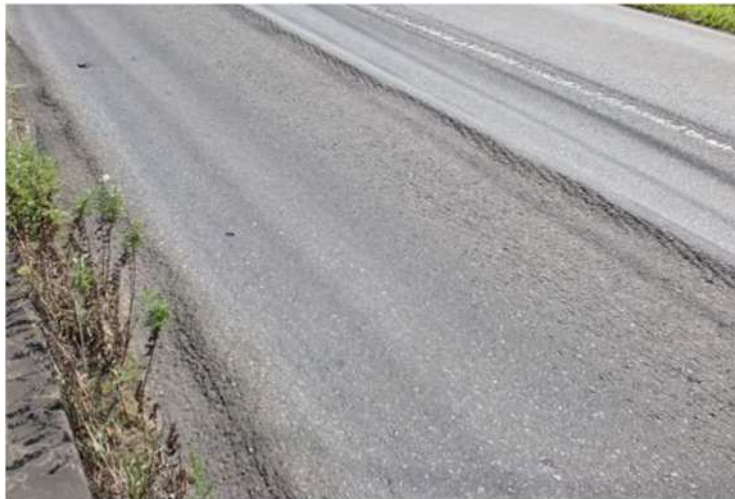
- The impact of passing vehicles accelerates compression deformation of the roadbed and subgrade, and the asphalt mixture follows, causing the wheel pass areas to become dented.
- The shape of the ruts is such that there is little bulge on the outside of the ruts, and the wheel pass areas often become dented and damaged with cracks.

Example of rutting caused by compressive deformation of roadbed/subgrade

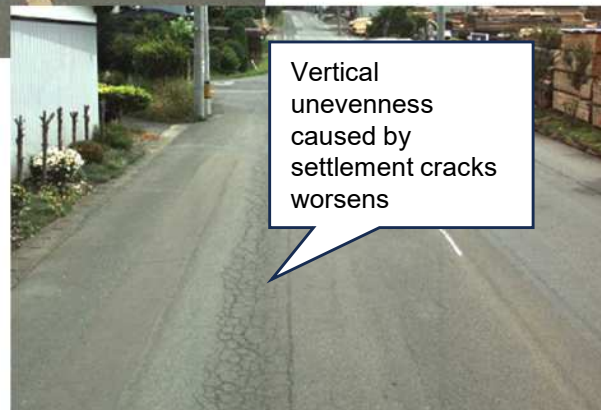
Vertical unevenness due to settlement cracks

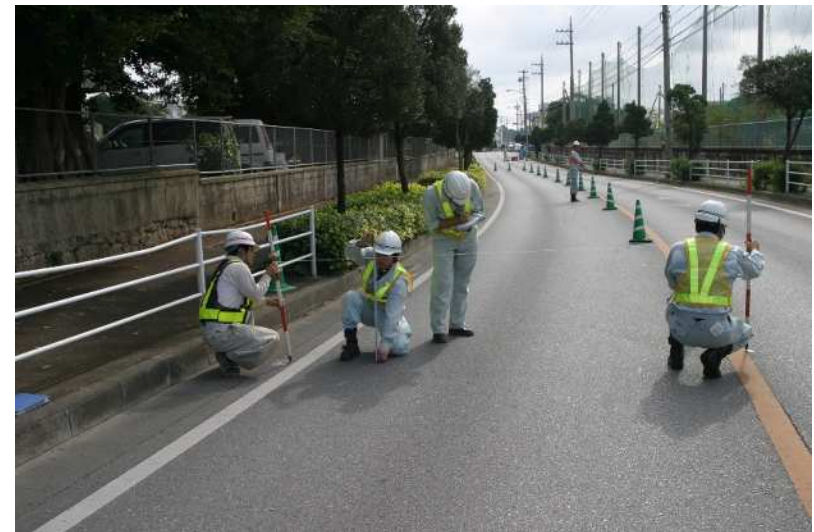
Using the outside of the shoulder lane markings of each lane as a reference point, measurements are taken at 20cm intervals in the transverse direction and the distance from the reference line to the road surface is read and recorded in mm.

Measurement of rutting depth

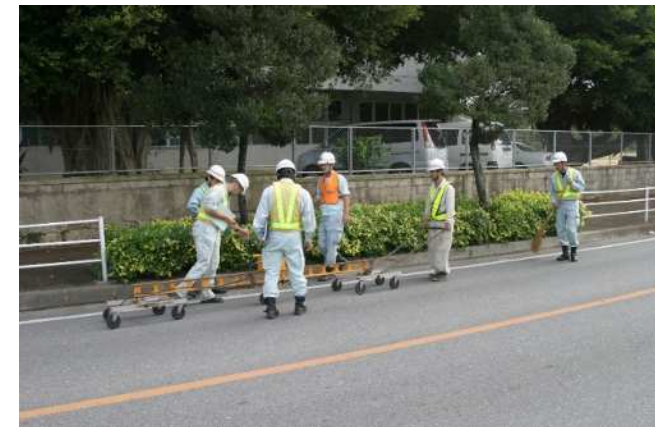
An index proposed by the World Bank in 1986 that correlates the road surface and the ride comfort of a driver.

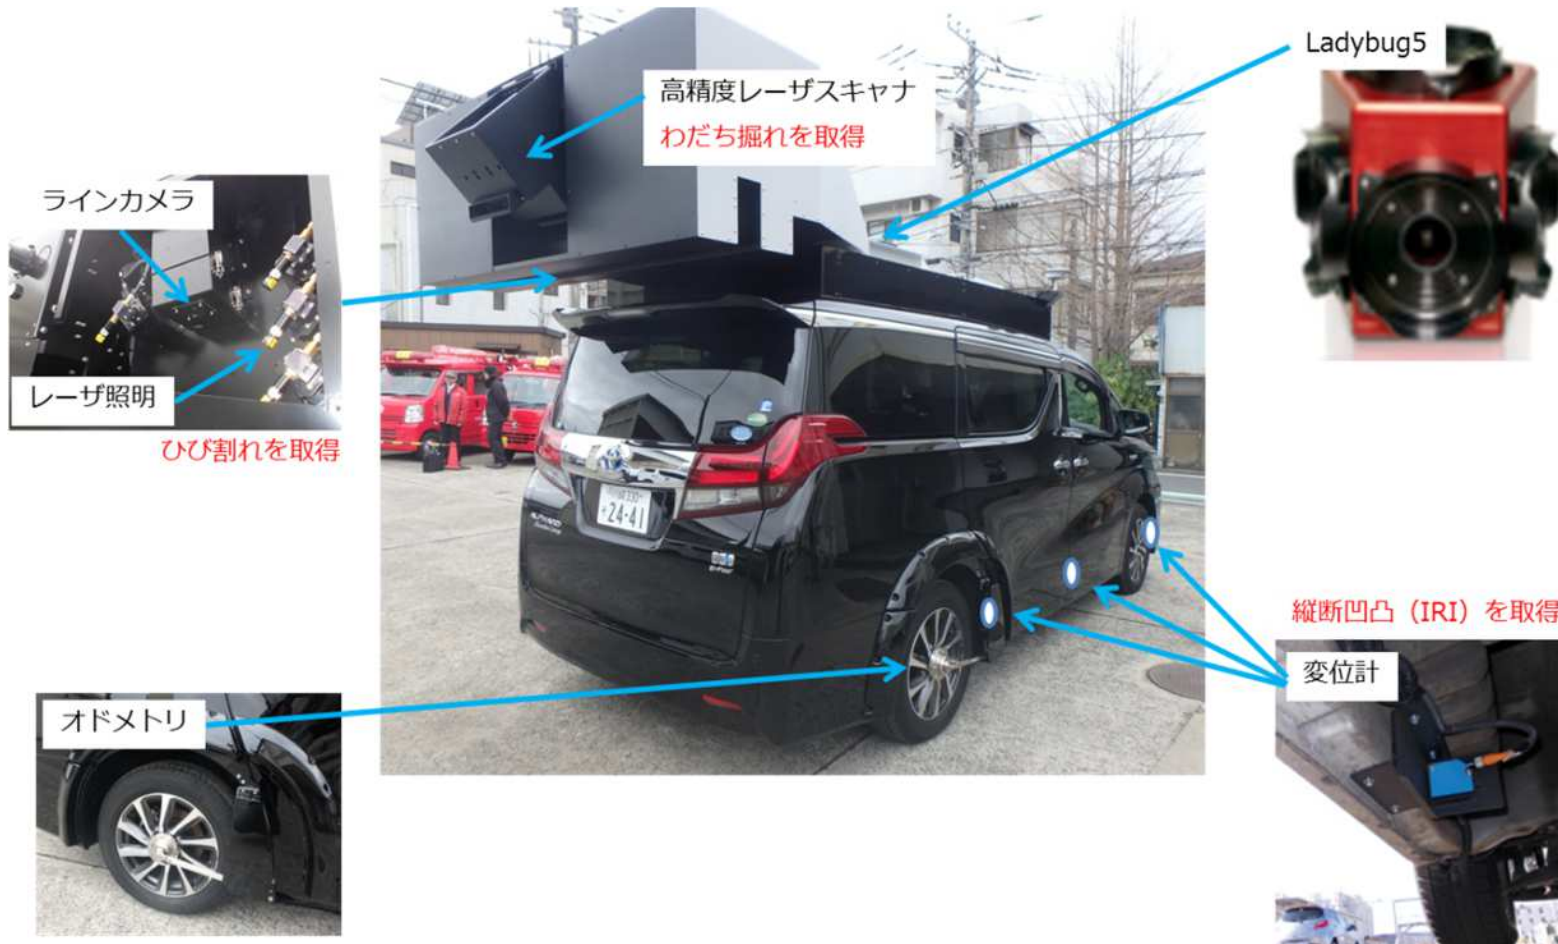
## 12. Road surface condition measurement vehicle

Road surface condition measurement vehicles are special vehicles equipped with sensors and cameras to measure road surface conditions. It is possible to measure road surface conditions such as cracks, ruts, and flatness ( $\sigma$ , IRI) of various roads such as expressways and national highways with high precision.

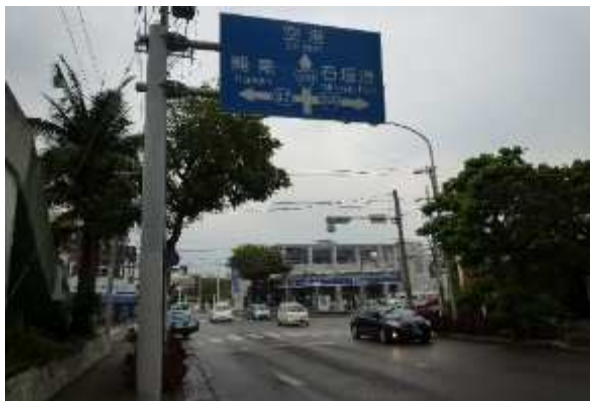
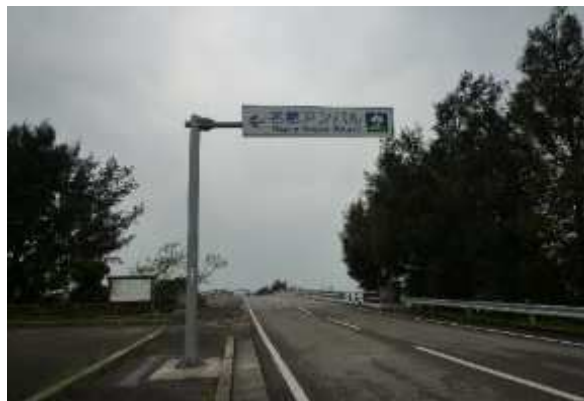
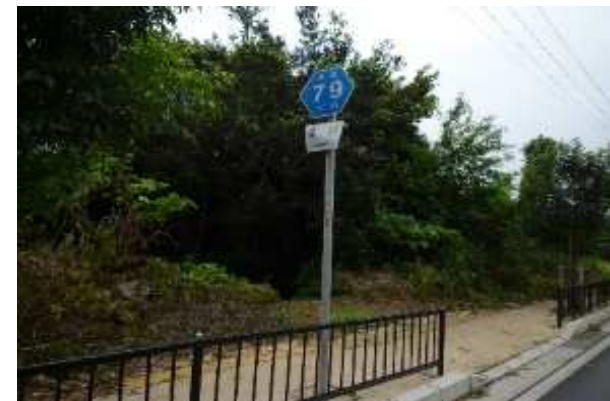
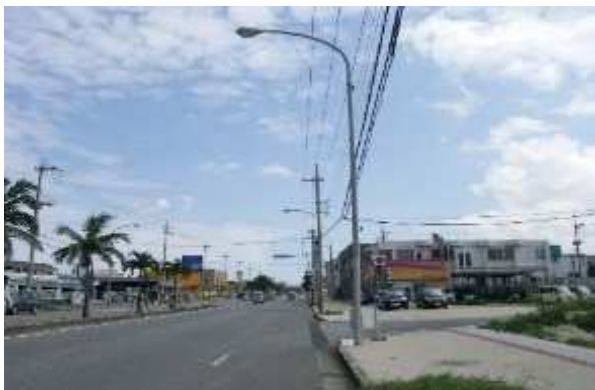
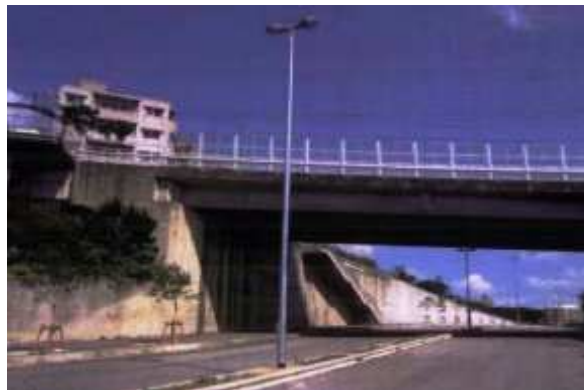
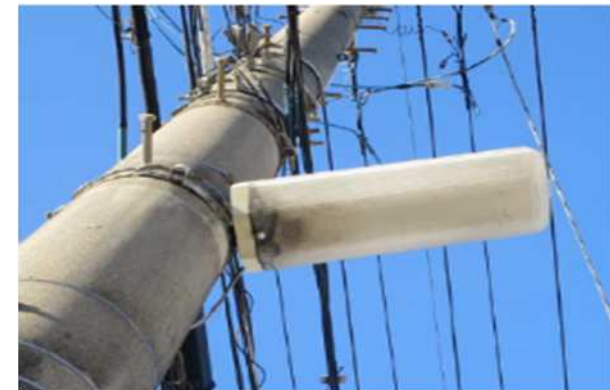
**Examples of accessories : Upper (road sign)  
Lower (road lighting)**

Regarding accessories, there have been cases of accidents such as falling light fixtures and collapsing pillars, and during inspections, special care must be taken to ensure that any abnormalities related to such accidents are detected.

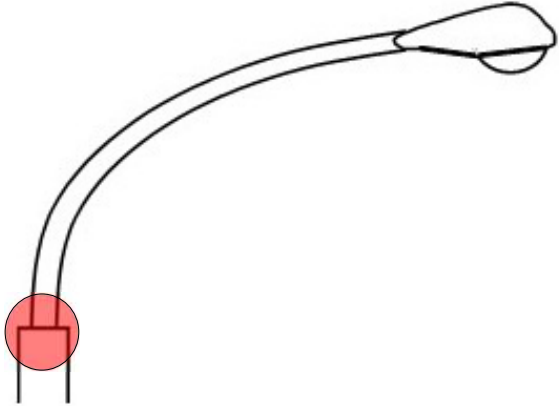
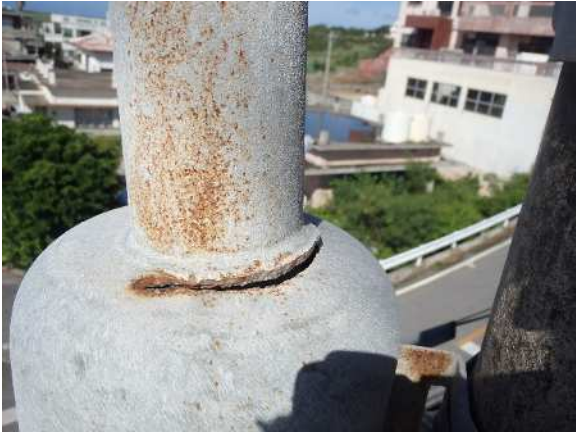
Pillar joint

Fatigue cracks occur due to vibrations caused by automobiles and wind.

If the cracks progress, they can cause fractures and lead to collapse.

<p>Cracks that occurred at the joint between the support and arm</p>
Pillar base

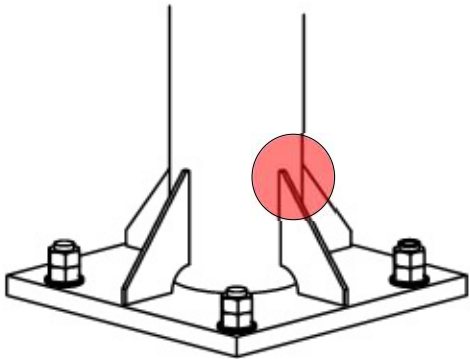
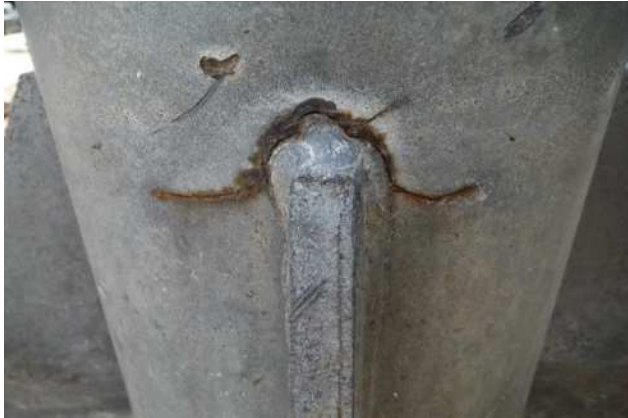
<p>Cracks in the rib attachment weld</p>

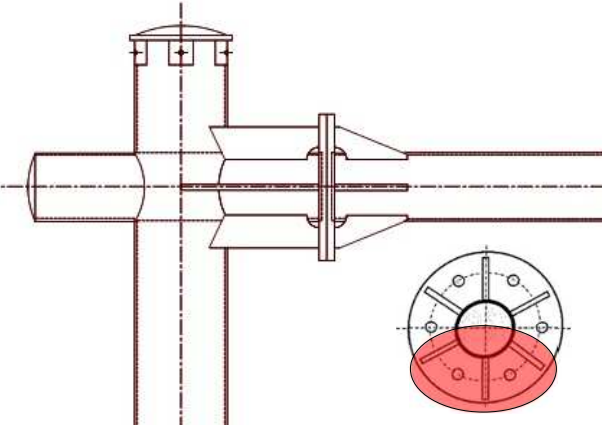
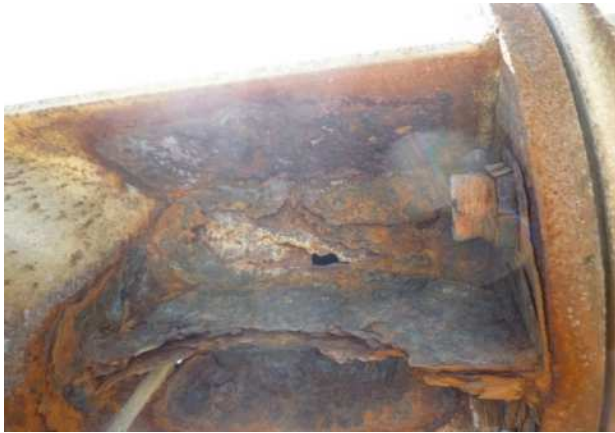
<p>Cross-beam mounting part</p>

Corrosion occurs due to stagnant water at the road surface boundaries and the effects of flying salt.

If corrosion occurs accompanied by a reduction in plate thickness, there is a risk of collapse.

<p>Corrosion occurred in the welded joints of the crossbeams</p>
<p>Pillar base</p>

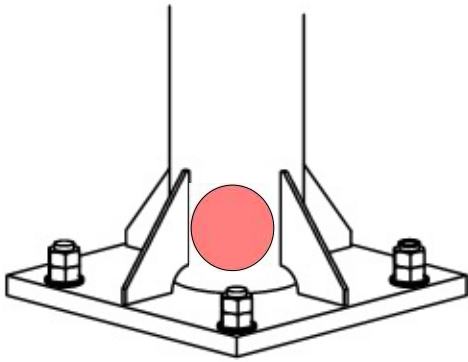
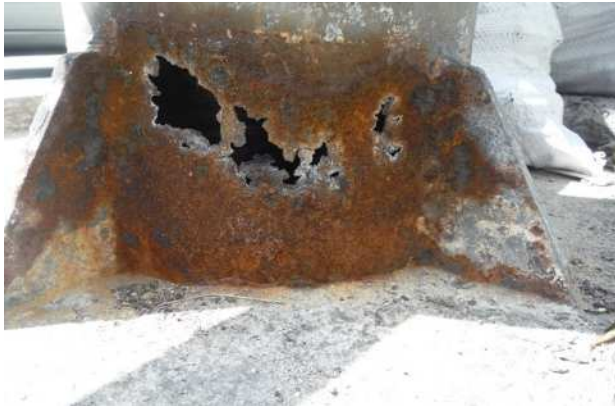
<p>Pitting caused by the progression of corrosion</p>

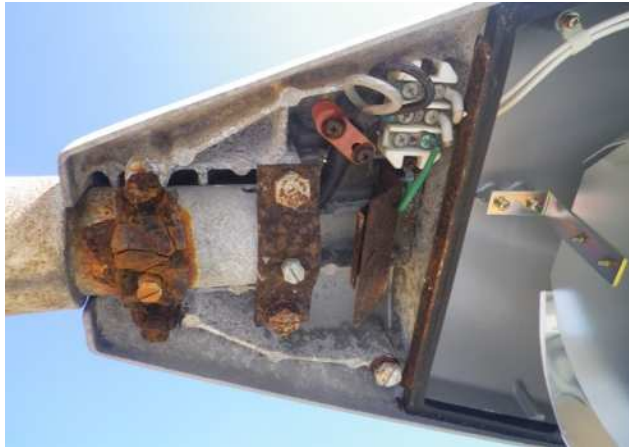
Corrosion due to dissimilar metal contact at the lamp mounting area

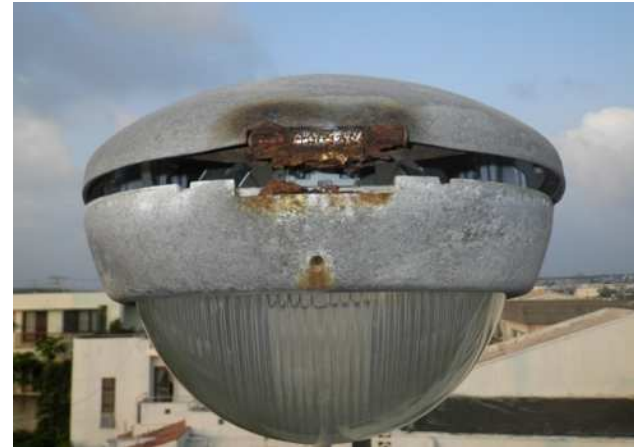
Breakage due to dissimilar metal contact corrosion at the opening of the lamp
