# Periodic inspection of road facilities

Okinawa Construction Technology Center

## § 1. bridge inspections

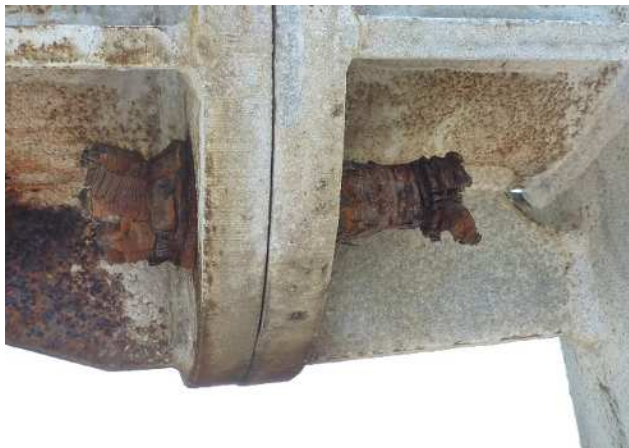
Bolt and nut breakage

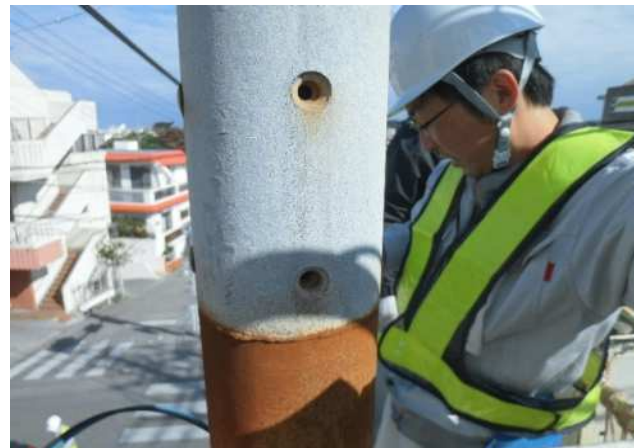
Bolt detachment at the pillar joint

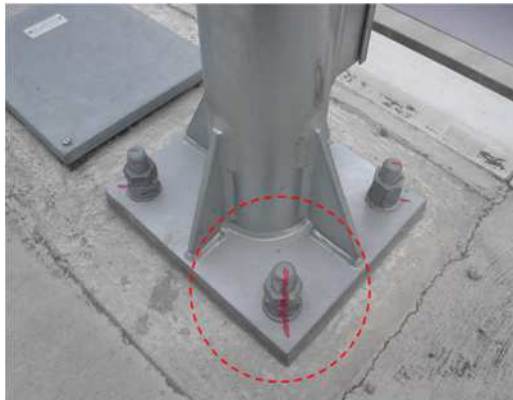
((Good example))

Match marks are a measure to visually check for loose bolts and nuts, and light or dark colored paint is used to make the marks easy to see.

The match marks are easy to see and are installed continuously on the bolts, nuts, and plates.

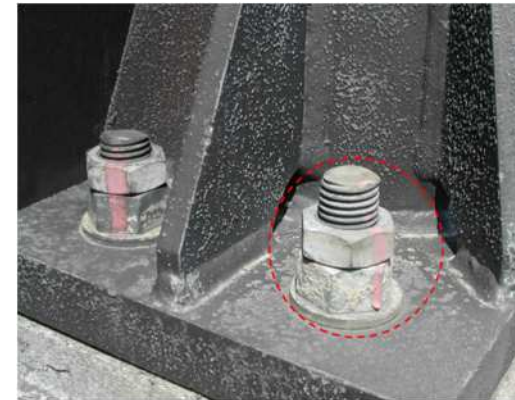
((Incorrect example))

The alignment marks are difficult to see and are only installed on the bolts.
